RECALL CAMPAIGN 16V-071: DRIVERS FRONT AIR BAG MODULE E70(X5) E71(X6) E72(X5 HYBRID)

This Service Information bulletin replaces SI B65 14 16 dated **May 2017**

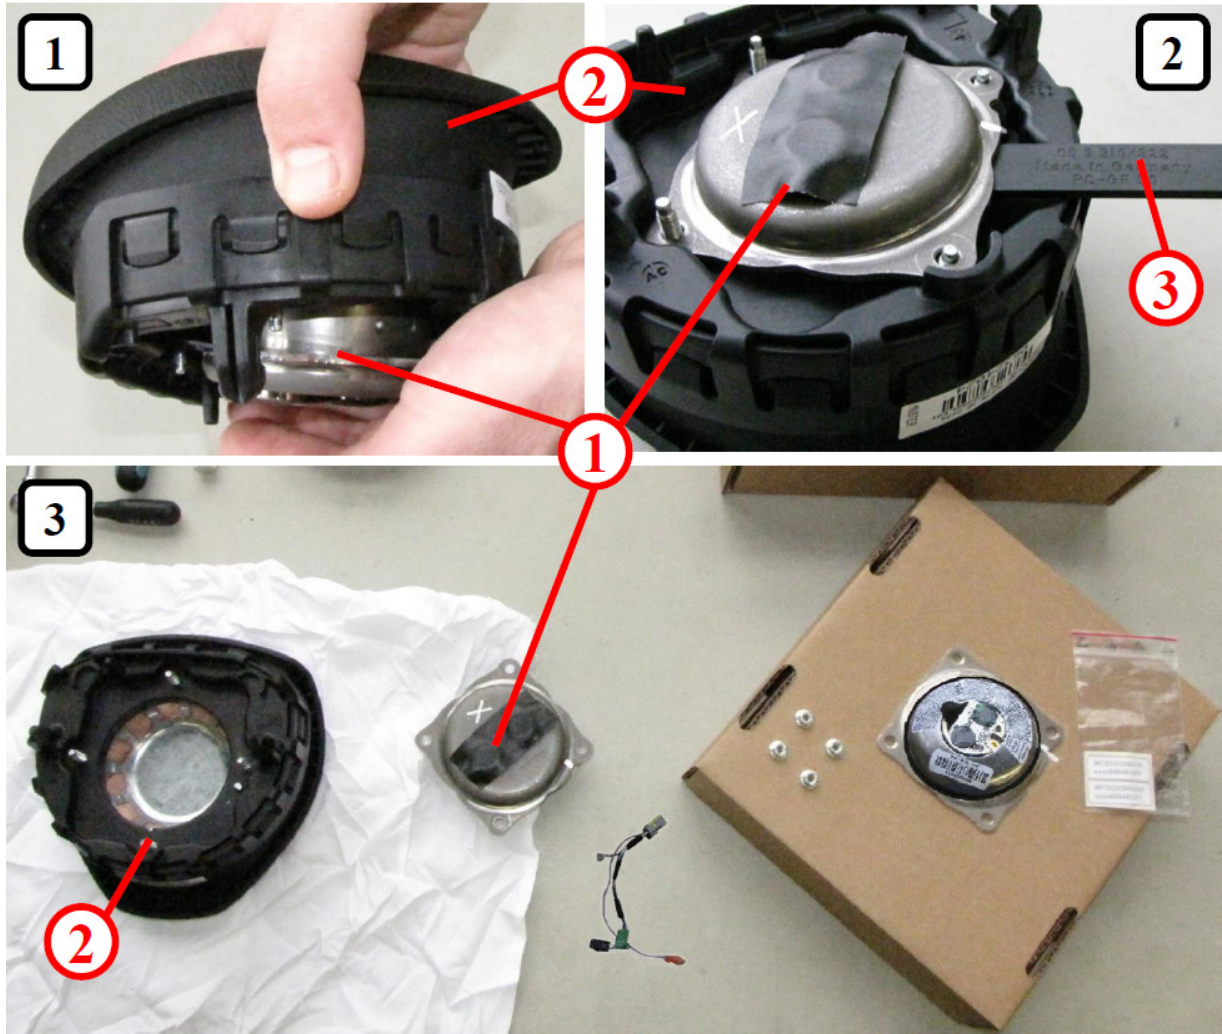
[12]

If the original Generator cannot be removed without excess force then cancel this procedure and replace the entire Air Bag assembly.

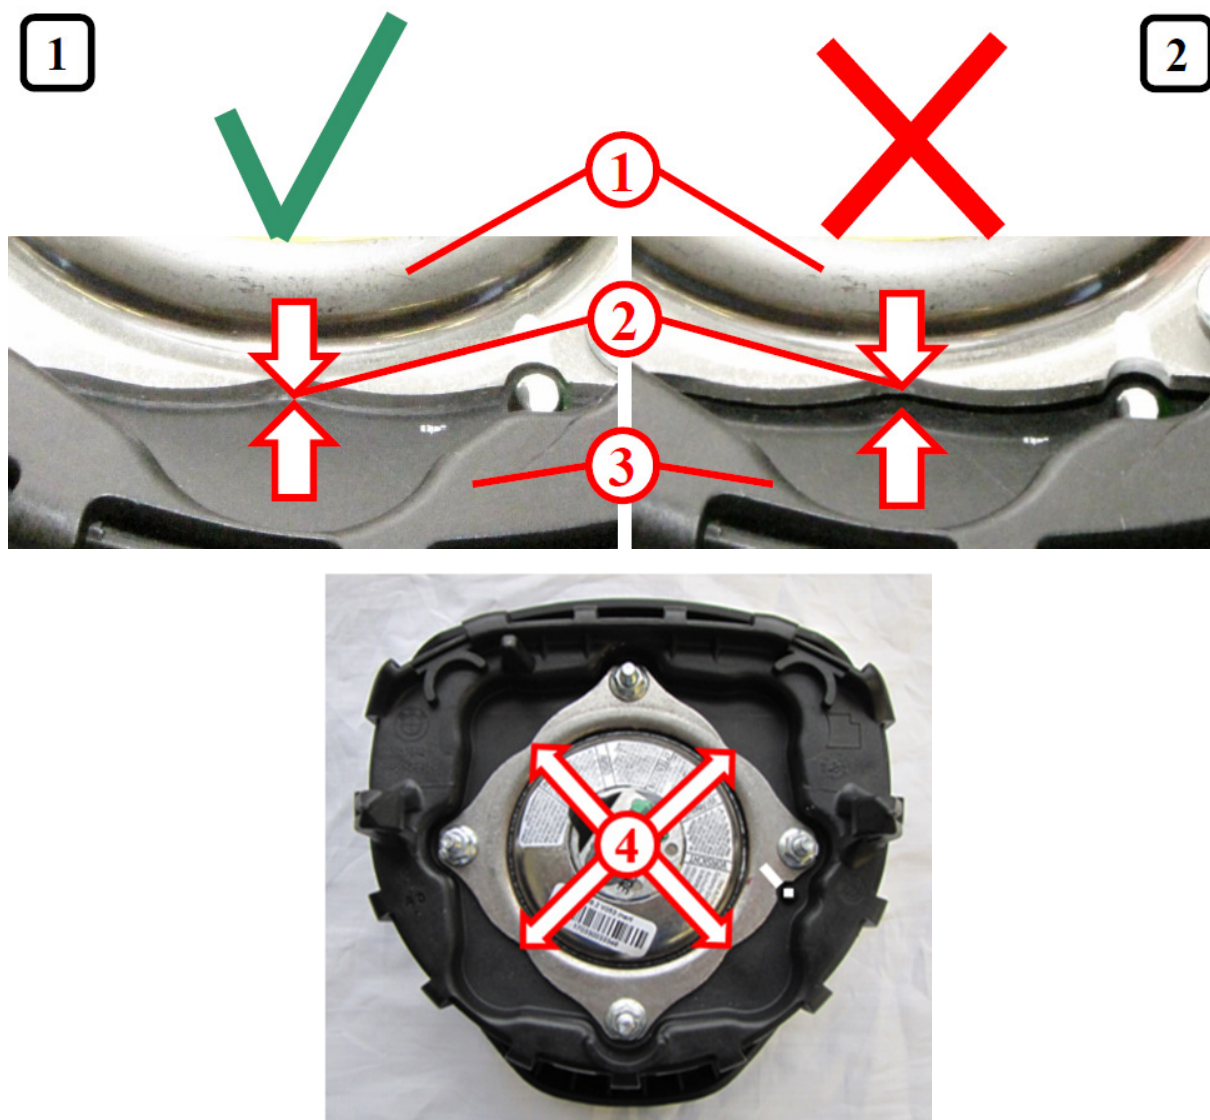
[17]

Perform a visual inspection of the gap (2) between the Generator (1) and the Air Bag (3) on all four sides of the Generator (4).

Picture (2) shows an improperly installed Generator with an excessive gap (2).

ATTENTION: If the gap cannot be closed up then cancel this procedure and replace the entire Air Bag assembly.
