SIB 65 09 17

## RECALL CAMPAIGN 16V-071: DRIVERS FRONT AIR BAG MODULE E84 (X1)

This Service Information bulletin (Revision 4) replaces SI B65 09 17 **dated October 2017**.

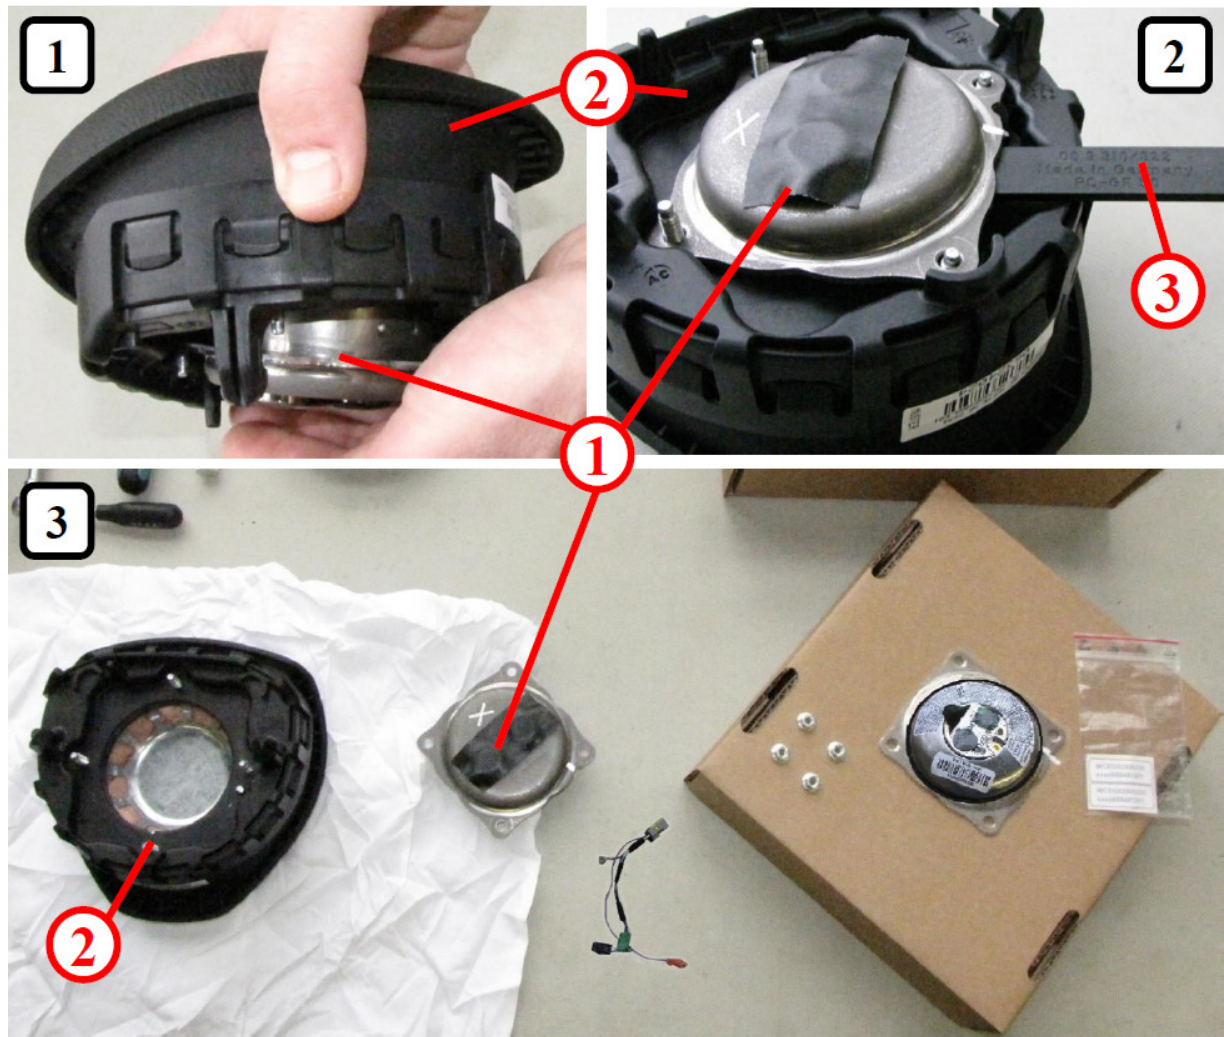
[12]

(1) Turn airbag over (2) and gently wiggle the Generator to remove from the airbag (2).

If the original Generator cannot be removed without excess force then cancel this procedure and replace the entire Air Bag assembly.

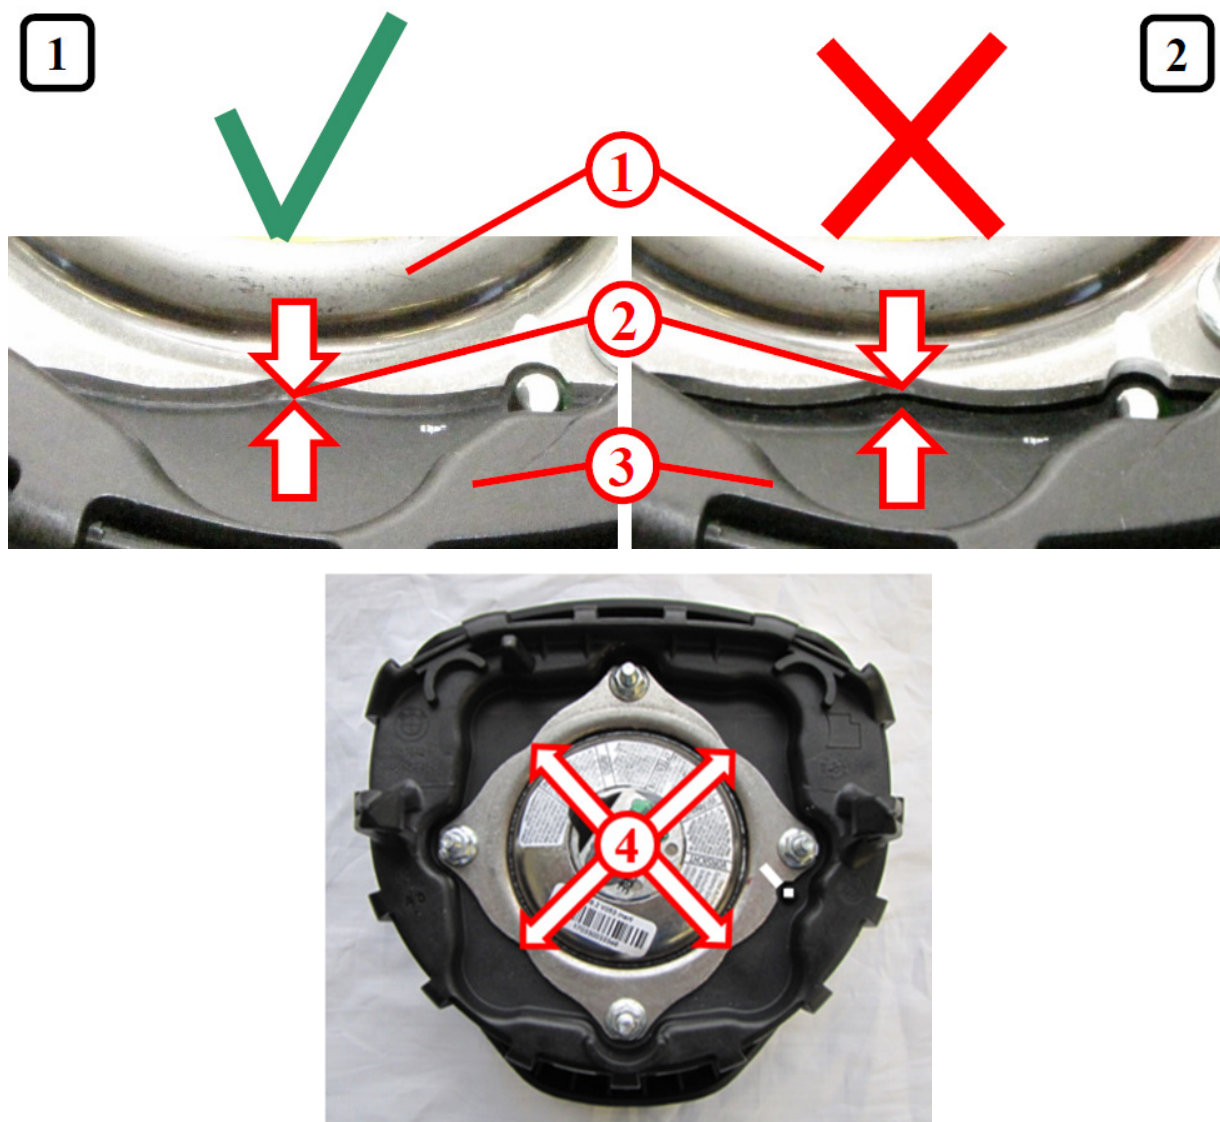
[17]

Perform a visual inspection of the gap (2) between the Generator (1) and the Air Bag (3) on all four sides of the Generator (4).

Picture (2) shows an improperly installed Generator with an excessive gap (2).

**ATTENTION:** If the gap cannot be closed up then cancel this procedure and replace the entire Air Bag assembly.
