RECALL CAMPAIGN 16V-071: DRIVERS FRONT AIR BAG MODULE E70 E71 E72 E84

This Service Information bulletin replaces SI B65 14 16 **dated December 2016**.

BMW AG is conducting a Voluntary Safety Recall involving the driver's front air bag module on certain BMW vehicles that are equipped with non-desiccated Takata PSDI-5 inflators. These vehicles, covering model years 2007-2015 have not been part of earlier Takata-related air bag recalls.

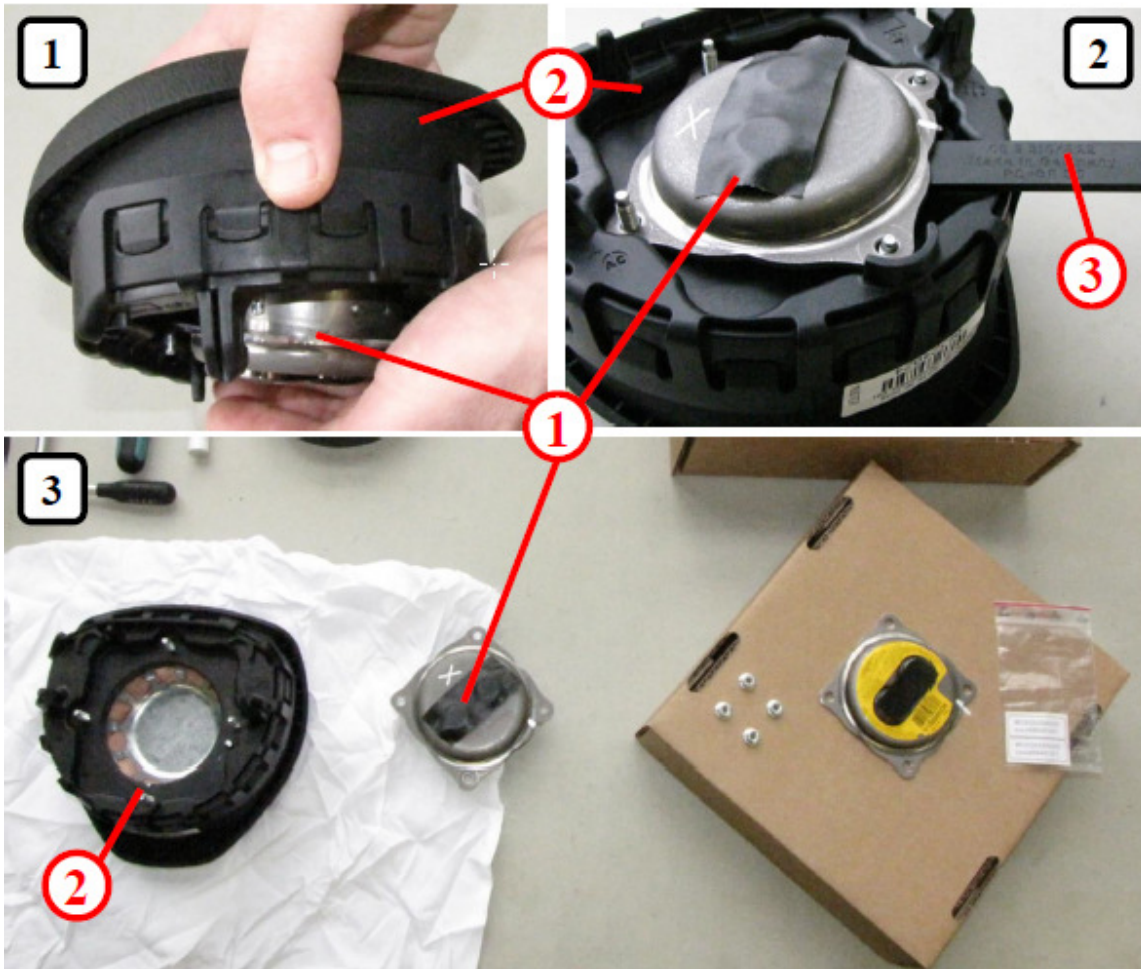
[12]

(1) Turn airbag over (2) and gently wiggle the Generator to remove from the airbag (2).

If the original Generator cannot be removed without excess force then cancel this procedure and replace the entire Air Bag assembly.

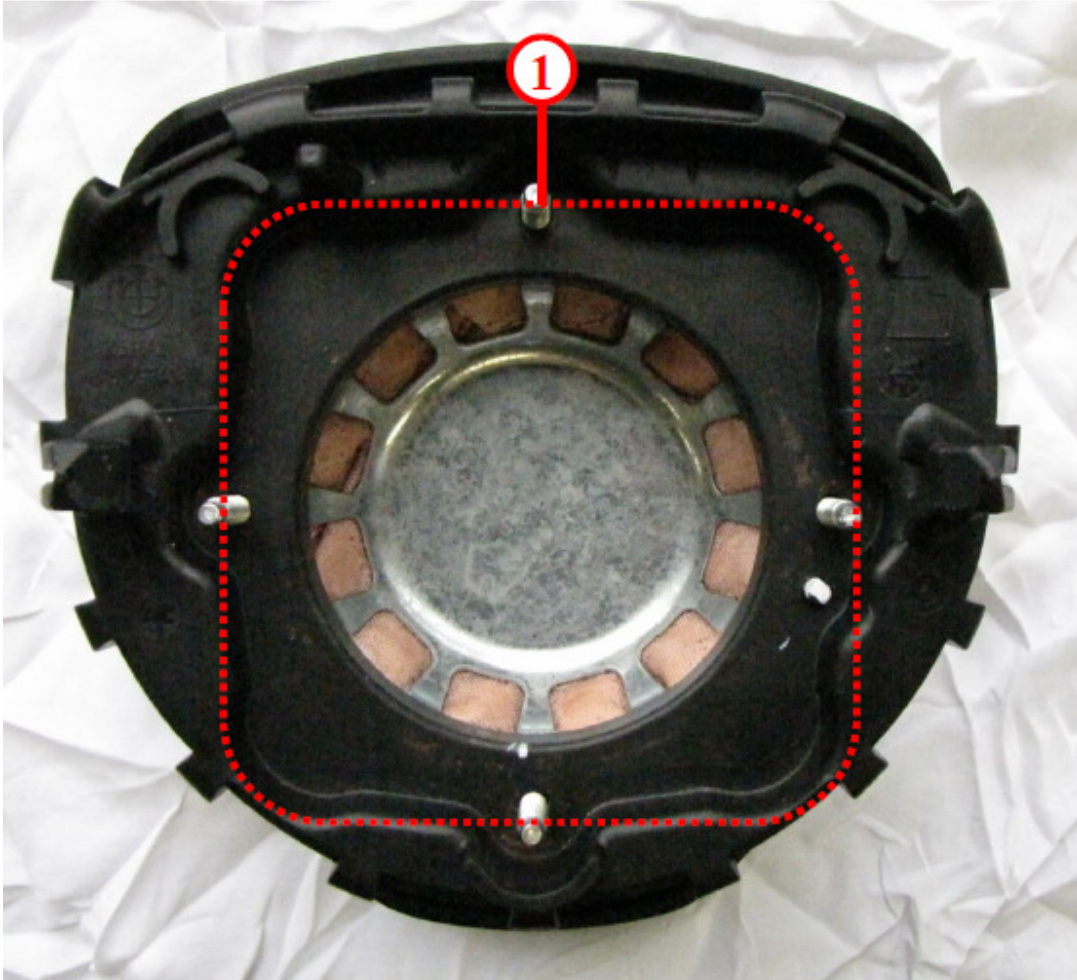
[13]

There may be a small amount of surface rust on the metal within the airbag. This is normal.

1st Technician should perform a visual inspection of the airbag cavity for foreign objects.

2nd Technician should perform a visual inspection of the airbag cavity for foreign objects.

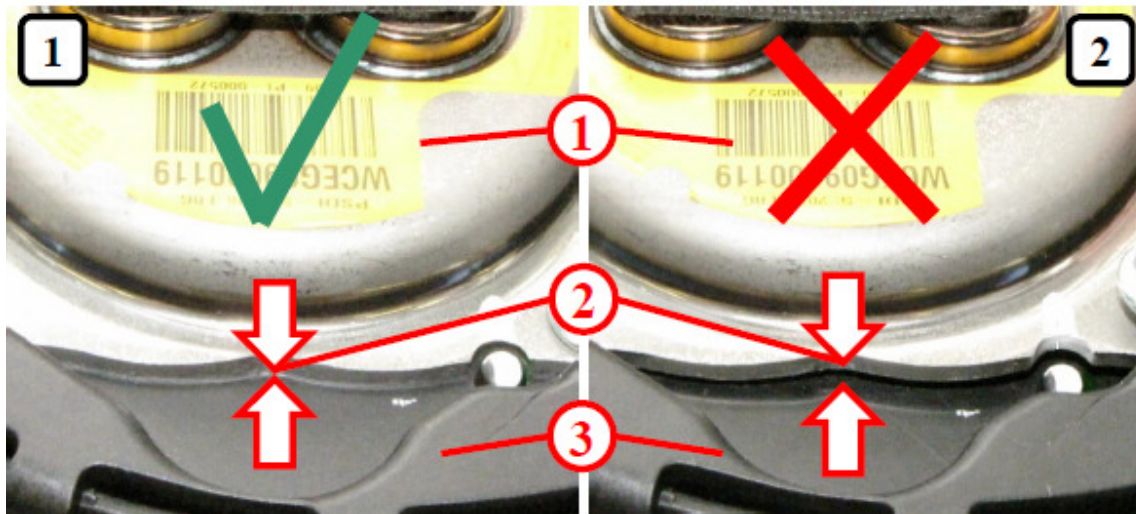
[17]

Perform a visual inspection of the gap (2) between the Generator (1) and the Air Bag (3) on all four sides of the Generator.

Picture (2) shows an improperly installed Generator with an excessive gap (2).

If the gap cannot be closed up then cancel this procedure and replace the entire Air Bag assembly.
