SI B65 14 16
Audio, Navigation, Monitors, Alarms, SRS

December 2016
Technical Service

RECALL CAMPAIGN 16V-071: DRIVERS FRONT AIR BAG MODULE E70 E71 E72 E84

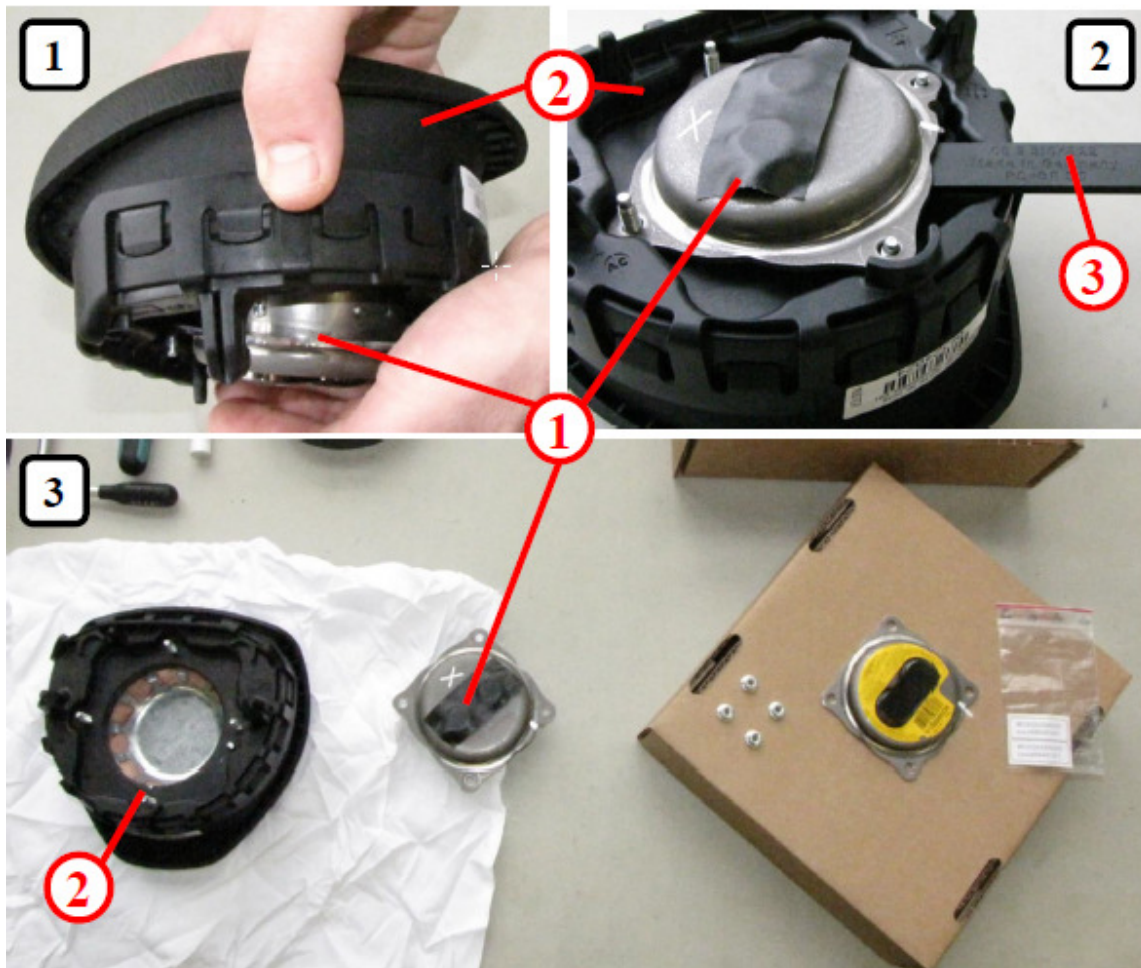
[12]

(1) Turn airbag over (2) and gently wiggle the Generator to remove from the airbag (2).

If the original Generator cannot be removed without excess force then cancel this procedure and replace the entire Air Bag assembly.

(3) After removal, place the original Generator next to the Air Bag.
