Safety Recall

Code: 69M8

Subject	TAKATA PSDI-5 Driver Frontal Airbag Inflator								
Release Date	March 8, 2017								
Affected Vehicles	U.S.A. & CANADA: Certain 2006-2007 MY Volkswagen Passat Sedan & Passat Wagon vehicles equipped with a Takata PSDI-5 driver frontal airbag <i>Check Campaigns/Actions screen in Elsa on the day of repair to verify that a VIN qualifies for repair under this action. Elsa is the <u>only</u> valid campaign inquiry & verification source.</i> <ul style="list-style-type: none">✓ Campaign status must show "open."✓ If Elsa shows other open action(s), inform your customer so that the work can also be completed at the same time the vehicle is in the workshop for this campaign.								
Takata Recall Priority Groups and Repair Rollout	<p>This recall is being managed according to the requirements mandated by the NHTSA in the Third Amendment to the Coordinated Remedy Order. Transport Canada is following the same requirements. Vehicles affected by this recall fall into the following priority groups established by the NHTSA as shown below:</p>

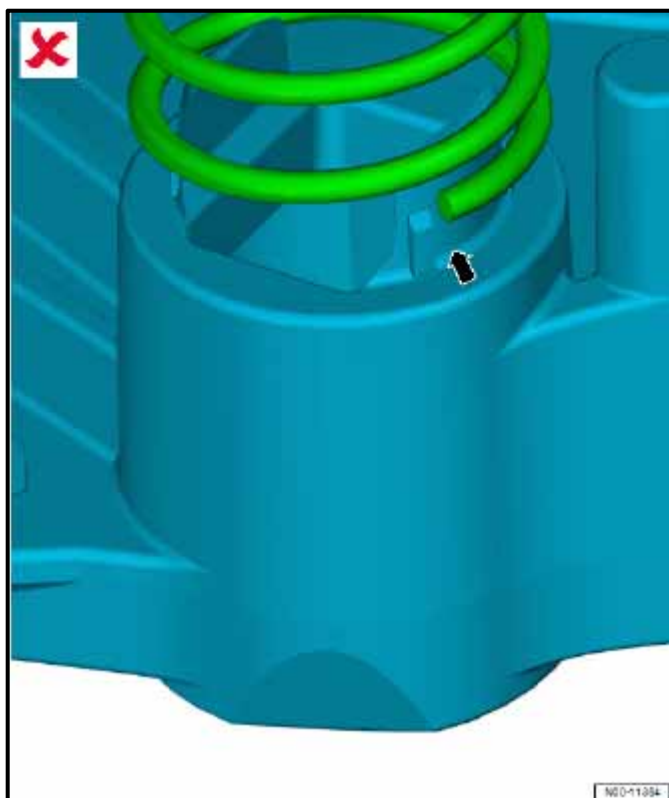
- Spring seated **incorrectly** <arrow>.

- If one of the springs is damaged or has been lost, it can be replaced with a spring from the bag of spares included.
- Note the examples shown for reference of proper spring seating.

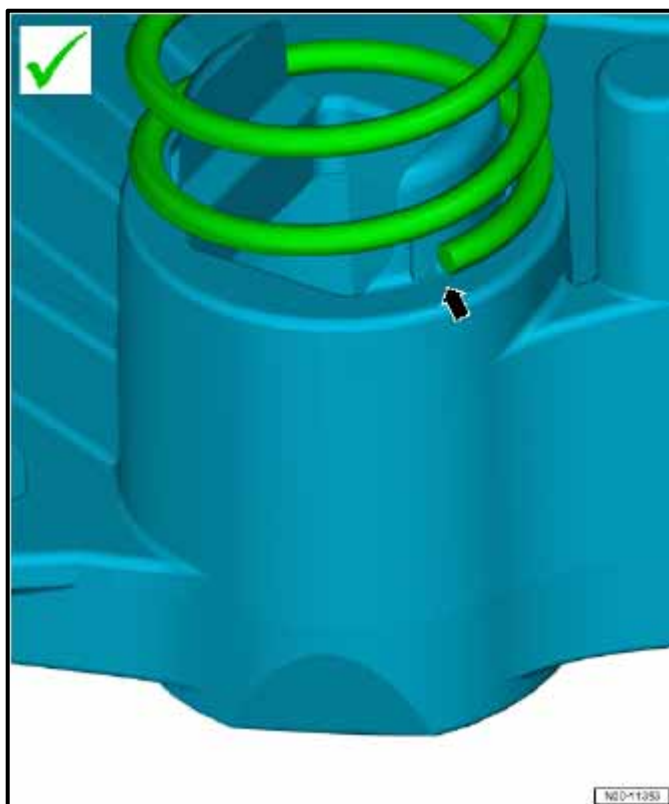
- Spring seated **correctly** <arrow>.

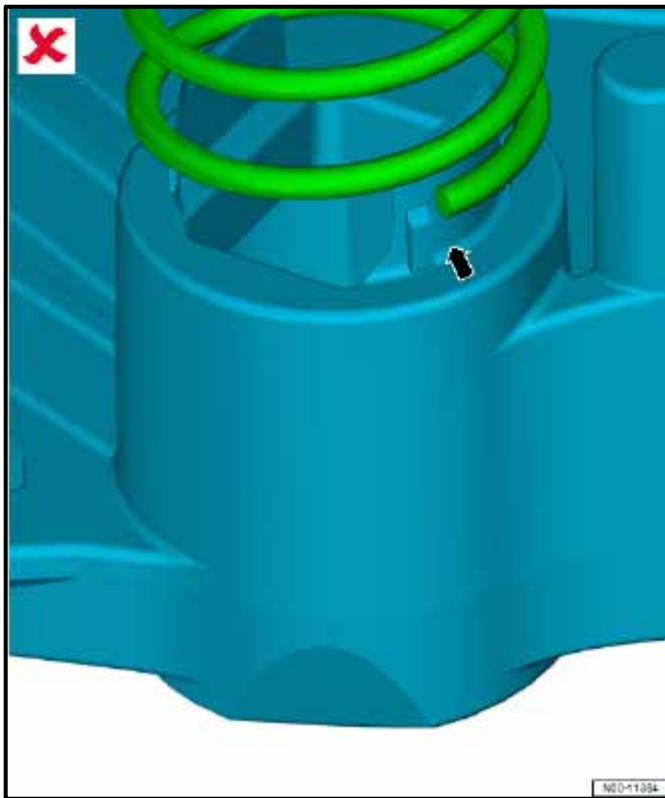
- Spring seated **incorrectly** <arrow>.

- If one of the springs is damaged or has been lost, it can be replaced with a spring from the bag of spares included.
- Note the examples shown for reference of proper spring seating.

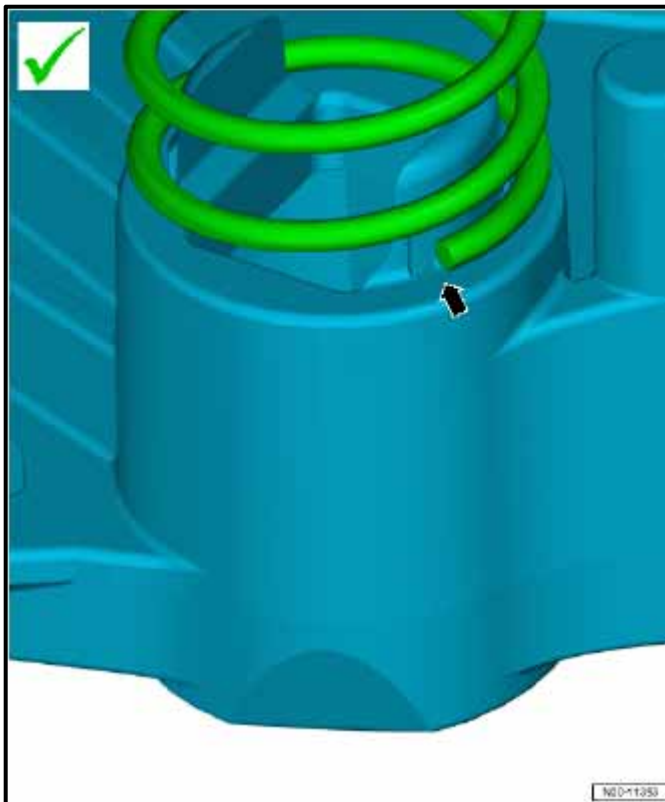
- Spring seated **correctly** <arrow>.
