Safety Recall **Code: 69M8**

REVISION	
Subject	TAKATA PSDI-5 Driver Fronta	I Airbag Inflator	
Release Date	April 7, 2017		
Revision Summary	Updated Priority Group 5 repa	ir availability.	
Affected Vehicles		2006-2007 MY Volkswagen Passat Sedan & Passat Wagon s equipped with a Takata PSDI-5 driver frontal airbag	
	Check Campaigns/Actions screen in E action. Elsa is the <u>only</u> valid campaig	Elsa on the day of repair to verify that a VIN qualifies for repair under this n inquiry & verification source.	
	 ✓ Campaign status must show "open." ✓ If Elsa shows other open action(s), inform your customer so that the work can also be completed at 		
		in the workshop for this campaign.	
Takata Recall Priority Groups and Repair Rollout	Third Amendment to the Coordin	ccording to the requirements mandated by the NHTSA in the nated Remedy Order. Transport Canada is following the same by this recall fall into the following priority groups established

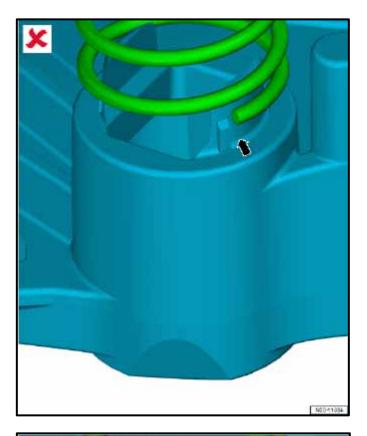
- If one of the springs is damaged or has been lost, • it can be replaced with a spring from the bag of spares included.
- Note the examples shown for reference of proper spring seating.
- Spring seated incorrectly <arrow>. •

- Spring seated correctly <arrow>.

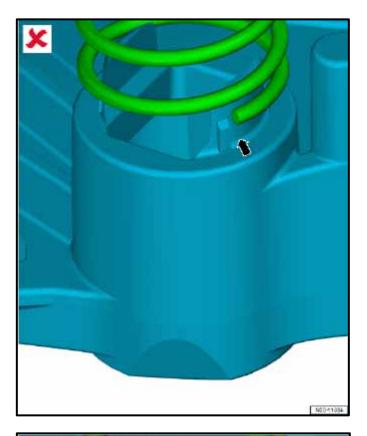
- If one of the springs is damaged or has been lost, • it can be replaced with a spring from the bag of spares included.
- Note the examples shown for reference of proper spring seating.
- Spring seated incorrectly <arrow>. •

- Spring seated correctly <arrow>.
