Revised March 2018

Safety Recall S15 / NHTSA 16V-081 Driver Airbag Inflator

2007-2008 (ZH) Chrysler Crossfire

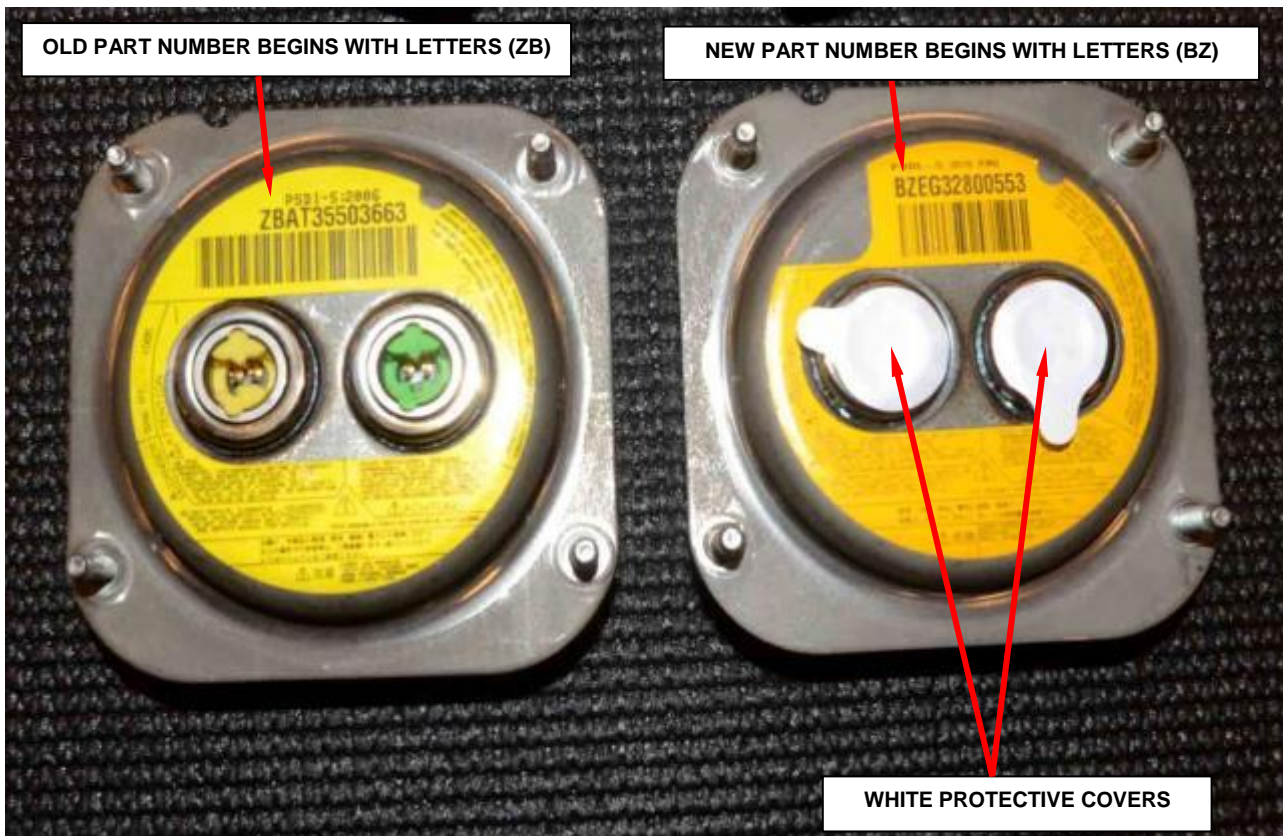
Figure 11 – Driver Airbag Inflator

NOTE: The difference between the OLD and the NEW inflators are the first two letters in the serial number on the caution label (Figure 11).

- **ZB OLD Part Number Letters**
- **BZ NEW Part Number Letters**

CAUTION: DO NOT remove the white protective covers from the airbag electrical receptacles on the NEW inflator at this time (Figure 11).
