# SAFETY RECALL

| Date | Number | Release | Page |
|---|---|---|---|
| 04.2016 | <b>RVXX1603</b> | <b>01</b> | 1 (4) |

## One Piece Steering Shaft, Replacement

VN

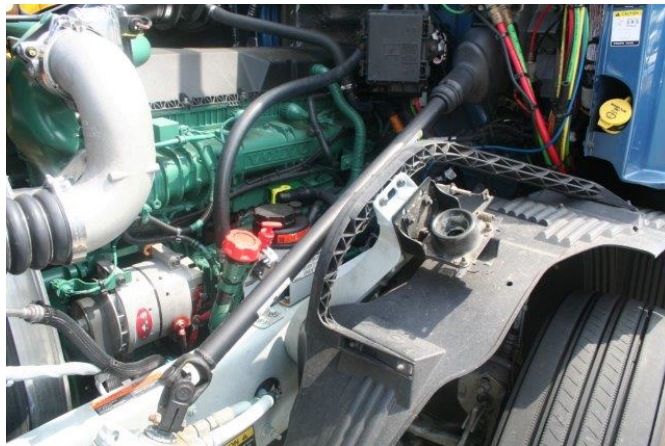
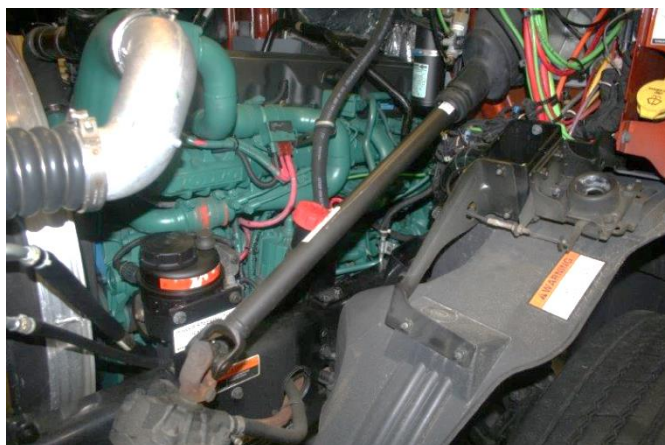
**NOTE:** The greaseable steering shaft (black in color) is shown below. The non-greaseable steering shaft (silver in color) is not shown.

10. Install the new shaft and new boot in from the engine compartment side

**NOTE:** See top image for VNL and bottom image for VNM.
