REPAIR PROCEDURE

APPLICABILITY: 2015-2016 MY Forester 2.0XT	NUMBER: WTA-62R
2015-2016 MY WRX	DATE: 03/17/16
SUBJECT: Repair Procedure for Subaru Recall	REVISED: 07/11/17
Campaign Stop-Sale: WTA-62 Turbocharger	NHTSA ID: 16V162
Air Intake Duct

INTRODUCTION

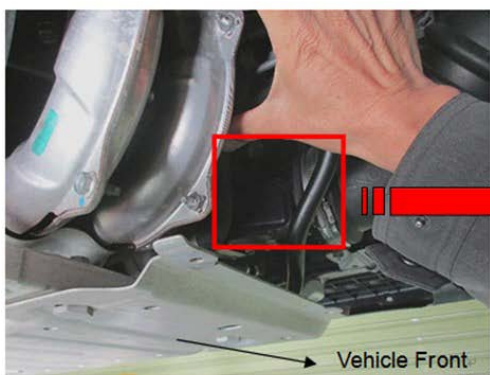
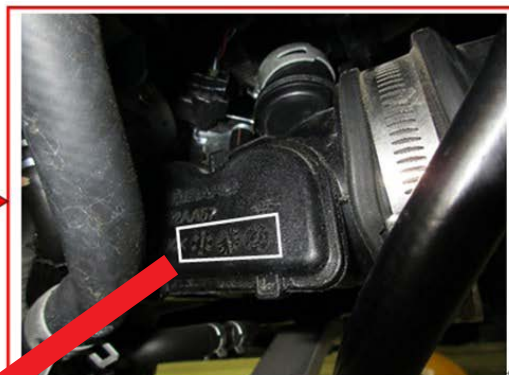
- Inspect the production date code of the turbocharger air intake duct as shown below.

IMPORTANT: Only turbocharger air intake ducts with a production date of **APRIL** (Month 4), 2015 require replacement. If the production date code is confirmed to be **OTHER THAN APRIL** (Month 4), the turbocharger air intake duct does **NOT** need to be replaced.

VERY IMPORTANT: If the production date code is confirmed to be **APRIL** (Month 4), the turbocharger air intake duct **must be replaced** following the repair procedure outlined below.

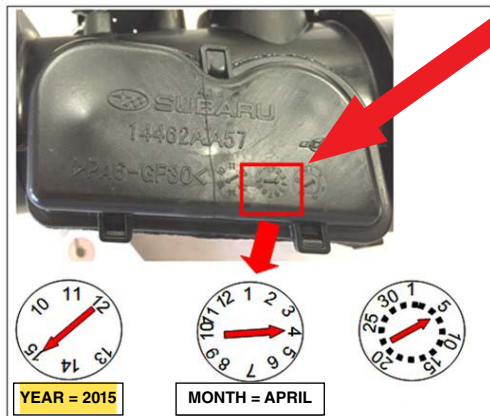
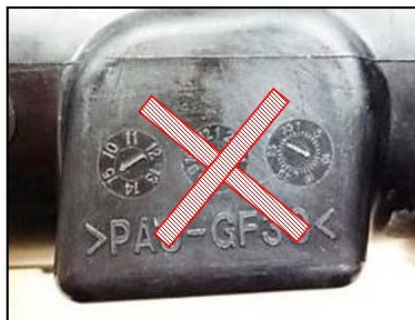
NOTE: Do not confuse this date code with the date code visible from the front of the vehicle.

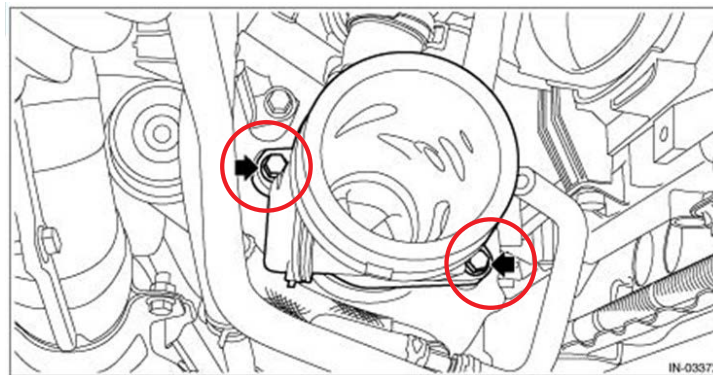
VERY IMPORTANT: Inspect the removed air intake duct closely for any cracking or damage. If the inspection shows the duct is cracked or has any pieces missing, the turbocharger impeller should be inspected closely for possible damage. If impeller damage is confirmed, the turbocharger assembly must also be replaced.

- Remove the 2 bolts securing the air intake duct to the turbocharger and remove it.
