APPLICABILITY: 2015-2016 MY Forester 2.0XT
2015-2016 MY WRX

NUMBER: WTA-62
DATE: 03/17/16

SUBJECT: Repair Procedure for Subaru Recall
Campaign Stop-Sale: WTA-62 Turbocharger
Air Intake Duct

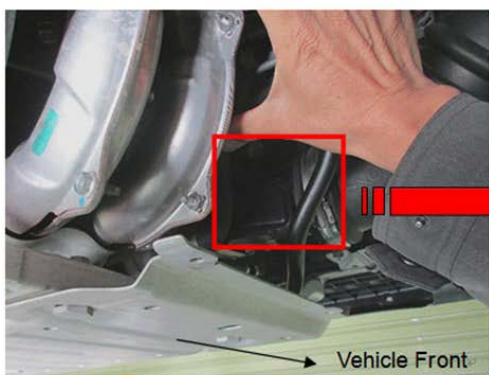
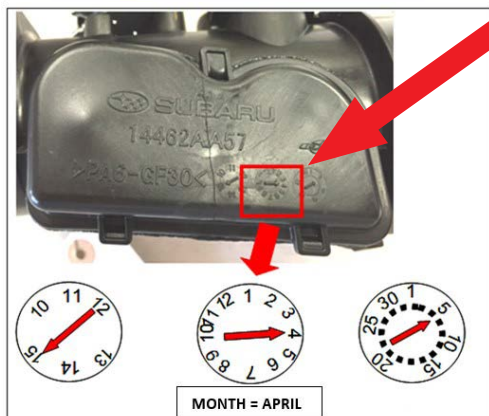
- Inspect the production date code of the turbocharger air intake duct as shown below.

IMPORTANT: Only turbocharger air intake ducts with a production date of **APRIL** (Month 4), 2015 require replacement. If the production date code is confirmed to be **OTHER THAN APRIL** (Month 4), the turbocharger air intake duct does **NOT** need to be replaced.

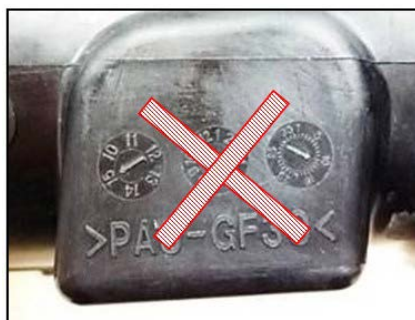
NOTE: Do not confuse this date code with the date code visible from the front of the vehicle.

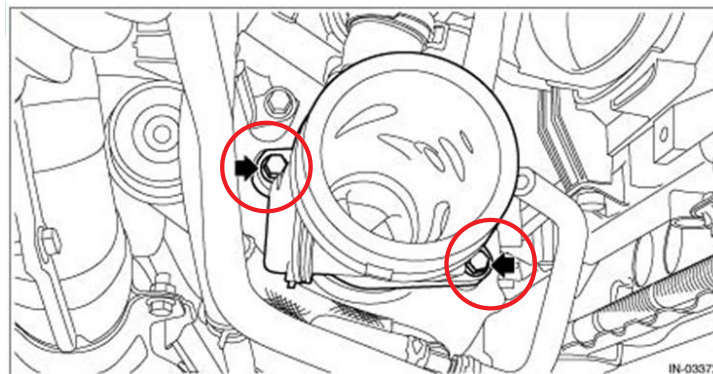
VERY IMPORTANT: Inspect the removed air intake duct closely for any cracking or damage. If the inspection shows the duct is cracked or has any pieces missing, the turbocharger impeller should be inspected closely for possible damage. If impeller damage is confirmed, the turbocharger assembly must also be replaced.

- Remove the 2 bolts securing the air intake duct to the turbocharger and remove it.
