PRODUCT CAMPAIGN BULLETIN

APPLICABILITY: 2015-2016 MY Forester 2.0XT
 2015-2016 MY WRX 2.0 DIT
SUBJECT: Turbocharger Air Intake Duct

NUMBER: WTA-62
DATE: April 4, 2016
NHTSA ID: 16V162

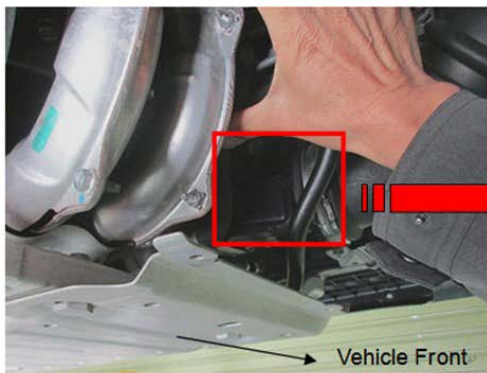
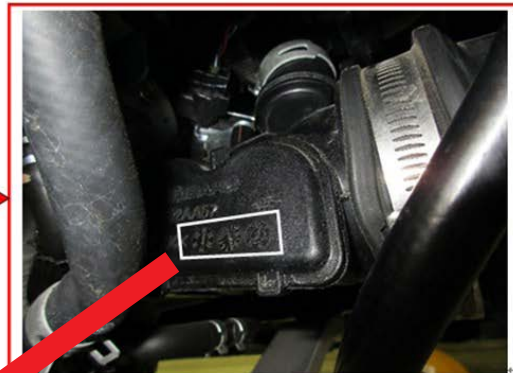
- Inspect the lot number (date) of the turbocharger air intake duct as shown below.

NOTE: Do not confuse this lot number (date) with the lot number (date) visible from the front of the vehicle.

IMPORTANT: Only turbocharger air intake ducts with a lot number (date) of **APRIL** (Month 4), 2015 require replacement. If the duct requires replacement based upon the date code, proceed to Replacement Procedure section. If the lot number (date) is confirmed to be **OTHER THAN APRIL, 2015** (Month 4), the turbocharger air intake duct does **NOT** need to be replaced. Continue on to undercover reinstallation.

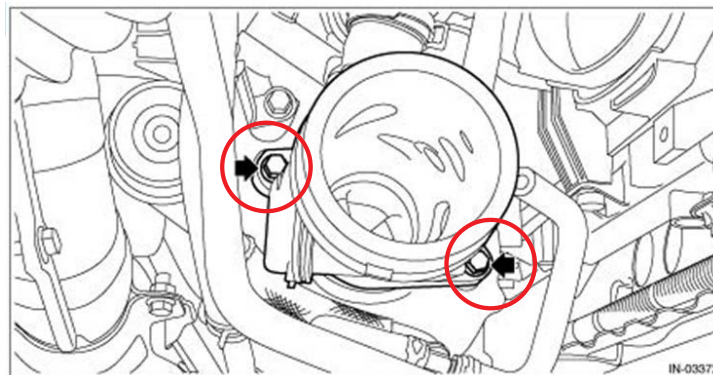
VERY IMPORTANT: Inspect the removed air intake duct closely for any cracking or damage. If the inspection shows the duct is cracked or has any pieces missing, the turbocharger impeller should be inspected closely for possible damage. If impeller damage is confirmed, the turbocharger assembly must also be replaced.

- Remove the 2 bolts securing the air intake duct to the turbocharger and remove it.
