PRODUCT CAMPAIGN BULLETIN

APPLICABILITY: 2015-2016 MY Forester 2.0XT
 2015-2016 MY WRX 2.0 DIT
SUBJECT: Turbocharger Air Intake Duct

NUMBER: WTA-62R
DATE: April 4, 2016
REVISED: July 11, 2017
NHTSA ID: 16V162

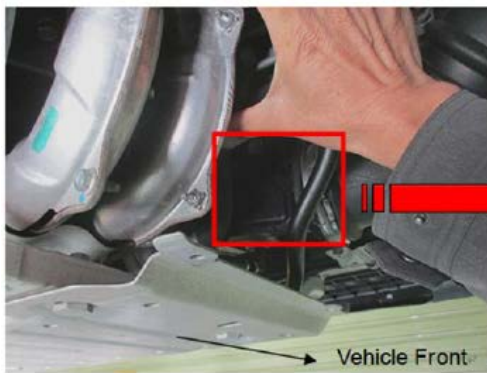
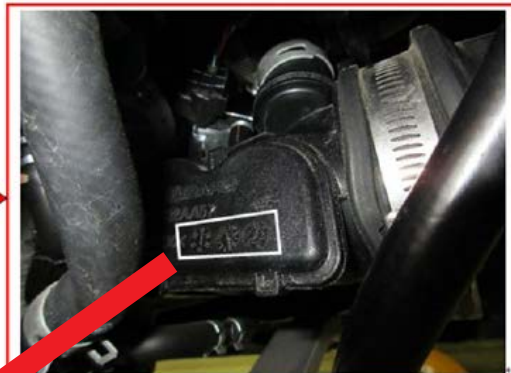
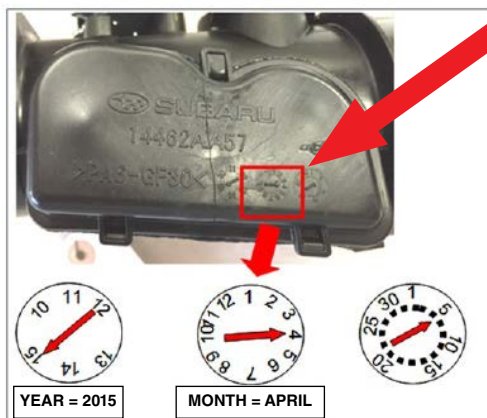
- Inspect the lot number (date) of the turbocharger air intake duct as shown below.

IMPORTANT: Only turbocharger air intake ducts with a lot number (date) of **APRIL** (Month 4), 2015 require replacement. If the duct requires replacement based upon the date code, proceed to Replacement Procedure section. If the lot number (date) is confirmed to be **OTHER THAN APRIL, 2015** (Month 4), the turbocharger air intake duct does **NOT** need to be replaced. Continue on to undercover reinstallation.

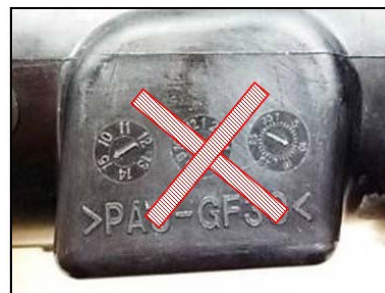
NOTE: Do not confuse this lot number (date) with the lot number (date) visible from the front of the vehicle.

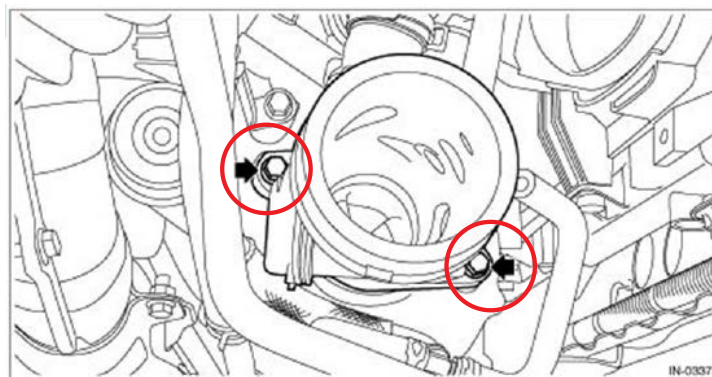
VERY IMPORTANT: Inspect the removed air intake duct closely for any cracking or damage. If the inspection shows the duct is cracked or has any pieces missing, the turbocharger impeller should be inspected closely for possible damage. If impeller damage is confirmed, the turbocharger assembly must also be replaced.

- Remove the 2 bolts securing the air intake duct to the turbocharger and remove it.
