Safety Action Recall Notice 534

Issue 1 - 03.2016

Subject: Fuel Tank Subharness				
Bulletin Number	Models Affected	VIN Range		Markets Affected
534	Street Twin	731919	739946	All Markets except Brazil
534	Bonneville T120	731919	739946	All Markets except Brazil

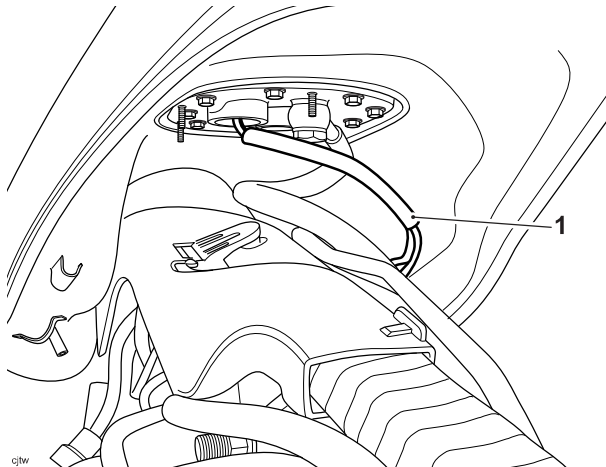
1. Batch code label

Internal investigations have identified the need to replace a subharness in the fuel tank to prevent a potential fuel leak. This only affects subharnesses with the following batch codes; **X111540044** or **X111540060**. Dealers are required to check the batch code on the subharness label. If the batch code does not match the affected batch codes, then no further action is needed.

4. Check the batch code label on the subharness.
5. If the batch code on the label is **X111540044** or **X111540060** then replace the subharness following the Replacing the Subharness procedure in this Safety Recall Action Notice.
6. If the batch code on the subharness does not match the affected batch codes, then no further action is needed.
7. Lower the tank into position making sure the breather pipe is not trapped.
8. Renew the lock nut and refit the fixings. Tighten the rear fuel tank mounting bolt to 8 Nm.
9. Refit the seat. Refer to the Street Twin or Bonneville T120 Service Manual.
