# Safety Recall

## Code: 23T3

| Subject | Connector Seal |
| Affected Vehicles | <b>U.S.A. &amp; CANADA: 2012-2014 MY Volkswagen Passat with TDI (Diesel) Engine</b><br><i>Check Campaigns/Actions screen in Elsa on the day of repair to verify that a VIN qualifies for repair under this action. Elsa is the <u>only</u> valid campaign inquiry &amp; verification source.</i> <ul style="list-style-type: none"><li>✓ Campaign status must show "open."</li><li>✓ If Elsa shows other open action(s), inform your customer so that the work can also be completed at the same time the vehicle is in the workshop for this campaign.</li></ul> |

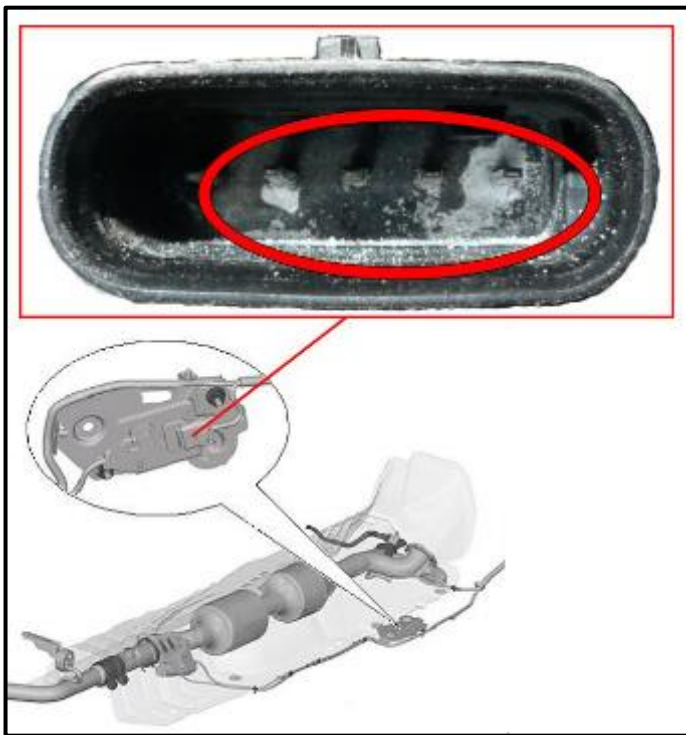
- Inspect the J583 control module terminals for corrosion and salt deposits <circled>.
  - o If corrosion and/or salt deposits **are found**, the J583 control module must be replaced. **Proceed to subsection A.**
  - o If corrosion and/or salt deposits **are not** found, connect the J583 control module connector to the J583 control module and continue with the procedure.
