TECHNICAL BULLETIN

J059NAS1

25 APR 2016

Safety Recall: AJ133 Cracked Fuel Pump Flange

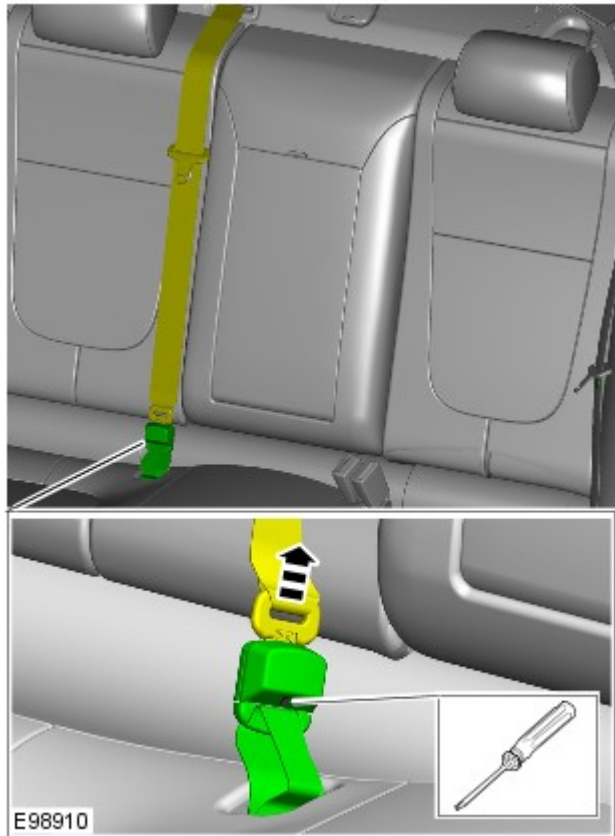
4. Release the rear seat center seatbelt.

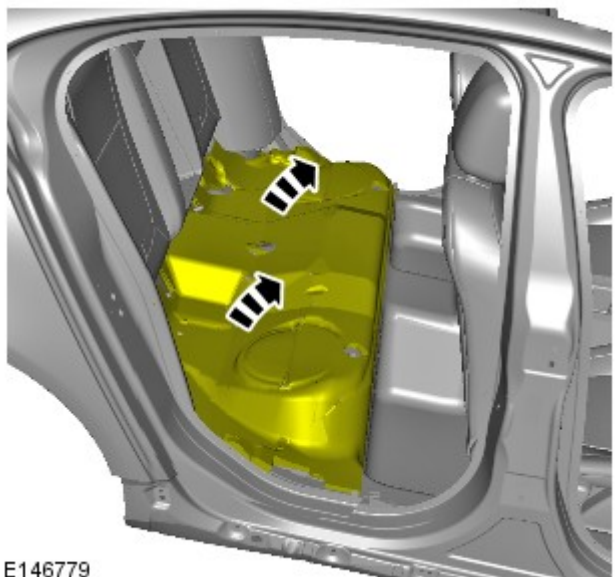
7. Reposition the rear floor covering.

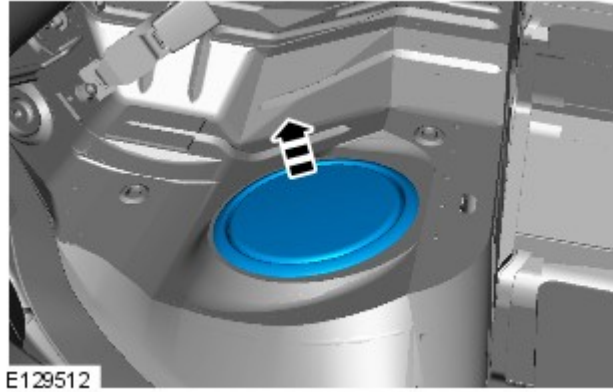
8. Remove the right-hand aperture cover.

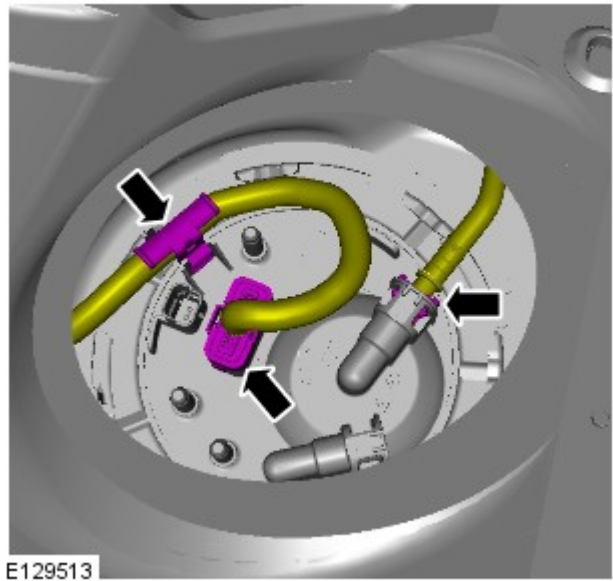
Disconnect the fuel tank connections.

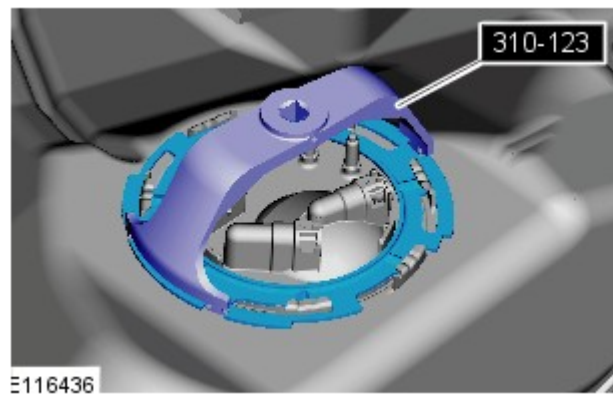
10. Using special tool **310-123** , remove the locking ring.

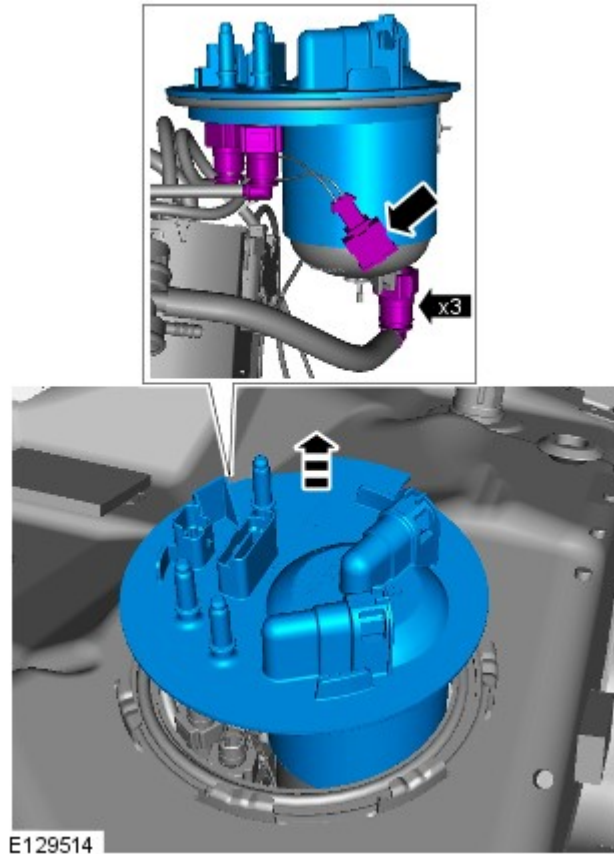
11. Remove and discard the fuel tank mounting flange.
