TO: All Mazda Dealership General Managers, Service and Parts Managers
DATE: May 2016
SUBJECT: 2016 CX-3, 2014-2016 CX-5, 2013-2015 CX-9 and 2013-2014 Mazda2
Front Suspension - Safety Recall 9316D

**CX-3, CX-5, CX-9, MAZDA2 FRONT SUSPENSION REPAIR
RECALL CAMPAIGN 9316D**

**2016 CX-3, 2014-2016 CX-5, 2013-2015 CX-9 and 2013-2014 Mazda2
Front Suspension - Safety Recall 9316D
NHTSA Campaign No. 16V-203**

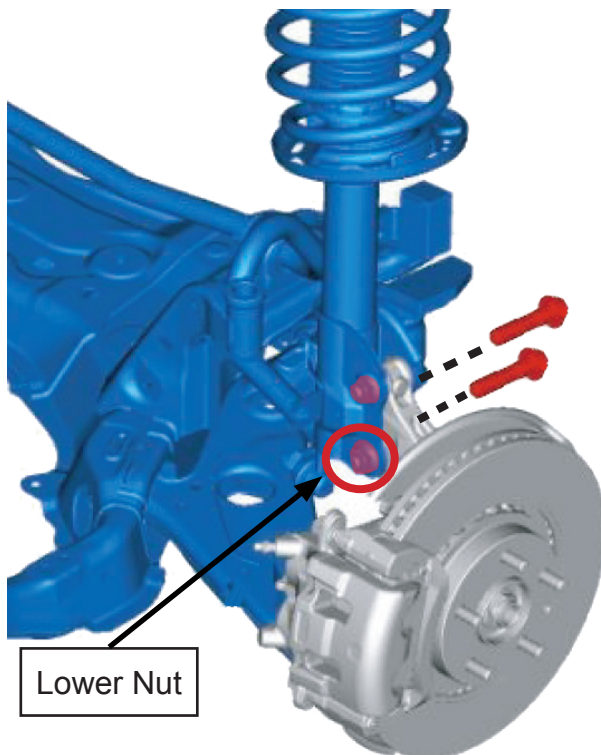
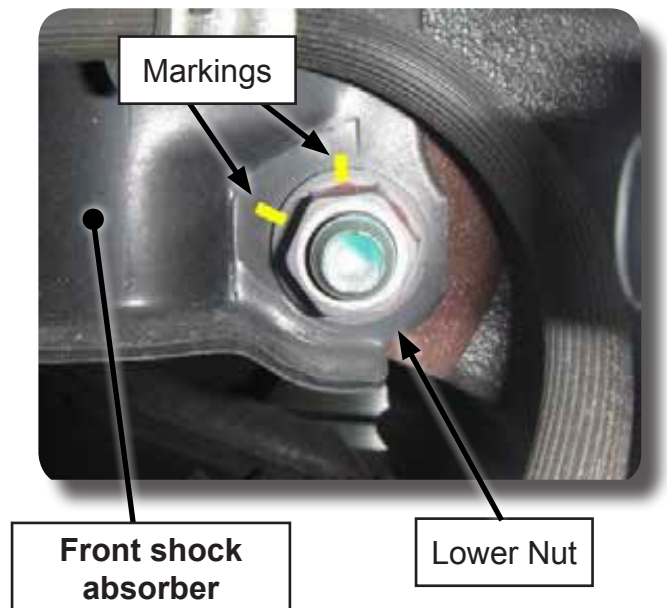
1. Lift up the vehicle and remove both front wheels.
2. Mark two points as shown. (Front suspension lower nuts and front shock absorbers on both sides)

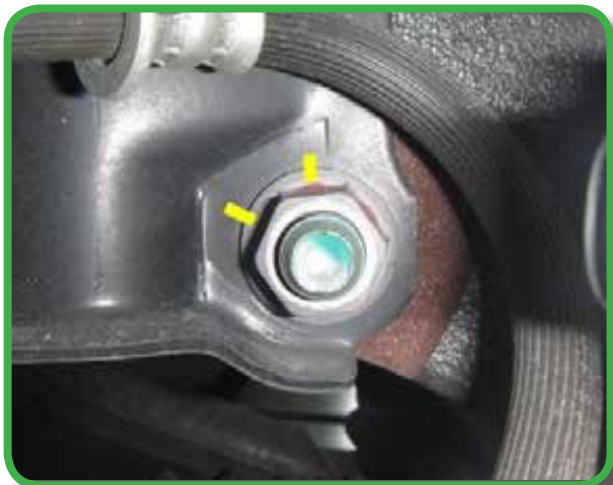
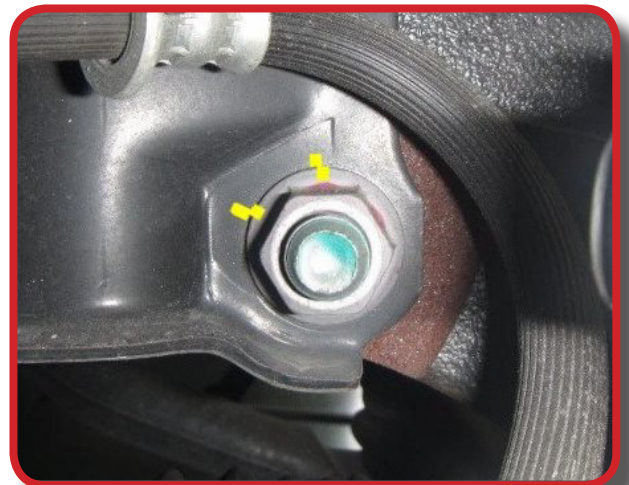
5. Inspect the paint marks from step 2 (both sides). Are the paint marks OK or NG?

OK

NG

- OK - Install any parts removed. Proceed to F. CAMPAIGN LABEL.
- No - Proceed to E. REPAIR PROCEDURE.
