<b>GROUP</b> <b>Safety Recall Campaign</b>	<b>MODEL</b> <b>2015~2016MY K900 (KH)</b>
	<b>NUMBER</b> <b>SC 130</b>	<b>DATE</b> <b>May 2016</b>
<b>VOLUNTARY SAFETY RECALL CAMPAIGN</b>		
<b>SUBJECT:           MULTI-FUNCTION SWITCH REPLACEMENT (SC 130)</b>

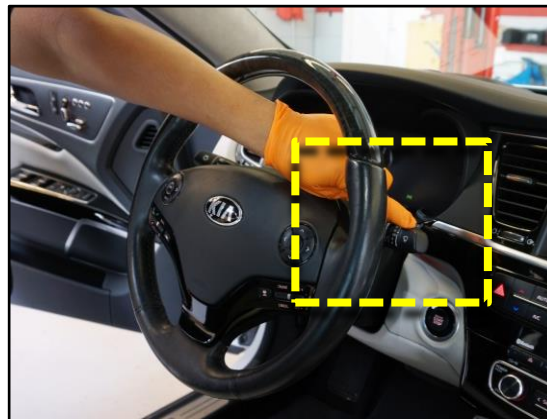
This bulletin provides the procedure to replace the Multi-Function Switch (see below) in certain 2015~2016MY K900 (KH) Luxury V8 vehicles, equipped with LED Headlights, and produced from December 18, 2013 through January 11, 2016. Use of the headlights in AUTO mode over time may result in increased electrical resistance of the contact points, which in turn may affect the operation of the Electronic Control Unit located inside the Multi-Function Switch. If this occurs, the headlights may flicker and/or intermittently turn off while driving. To correct this condition, follow the procedure outlined in this bulletin. Before conducting the procedure, verify the vehicle is included in the list of affected VINs.
