## **RECALL CAMPAIGN BULLETIN**

NTB16-053b

## VOLUNTARY SAFETY RECALL CAMPAIGN 2013-2016 SENTRA OCCUPANT CLASSIFICATION SYSTEM REPROGRAMMING SEATBELT BUCKLE BRACKET INSTALLATION

APPLIED VEHICLE: 2013-2016 Sentra (B17)

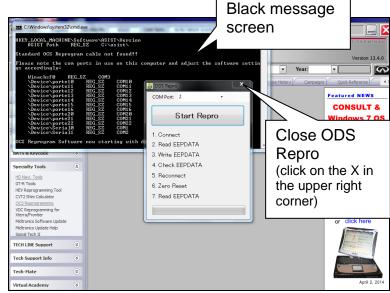
**NOTE**: If you get a black message screen as shown in Figure 26, this indicates that the reprogramming cable is not connected, or the cable driver did not install correctly.

- a. Close ODS Repro.
- b. Close ASIST.
- c. Start over from step 1 on page 13.
