RECALL CAMPAIGN BULLETIN

NTB16-054a

VOLUNTARY SAFETY RECALL CAMPAIGN OCCUPANT CLASSIFICATION SYSTEM CONTROL UNIT REPLACEMENT

CAMPAIGN ID #: R1607

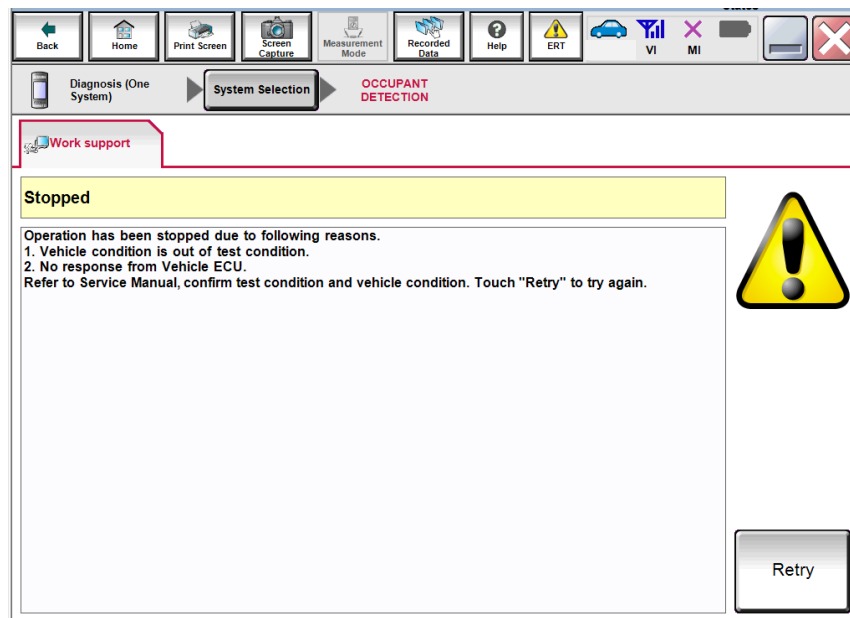
- After selecting **Start** if Figure 14 is displayed:
 - a. Check the OCS control unit and confirm that harness connector is completely seated.
 - b. Turn the ignition OFF and then restart procedure from step 4 on page 9.

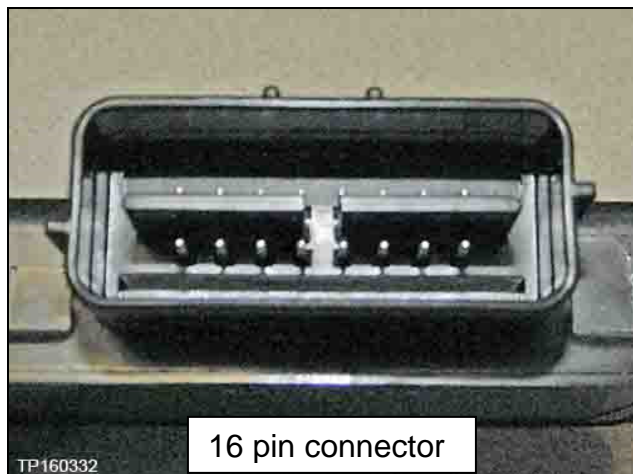
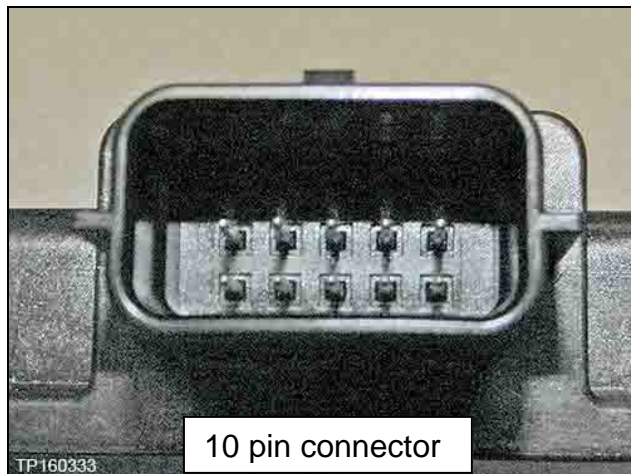
(1) Confirm that the number of pins of the new part are the same as the original (see Figures 17 and 18 on the next page).
