# RECALL CAMPAIGN BULLETIN

NTB16-052a

## VOLUNTARY SAFETY RECALL CAMPAIGN OCCUPANT CLASSIFICATION SYSTEM REPROGRAMMING

**CAMPAIGN ID #:** R1609**NHTSA #:** 16V-244

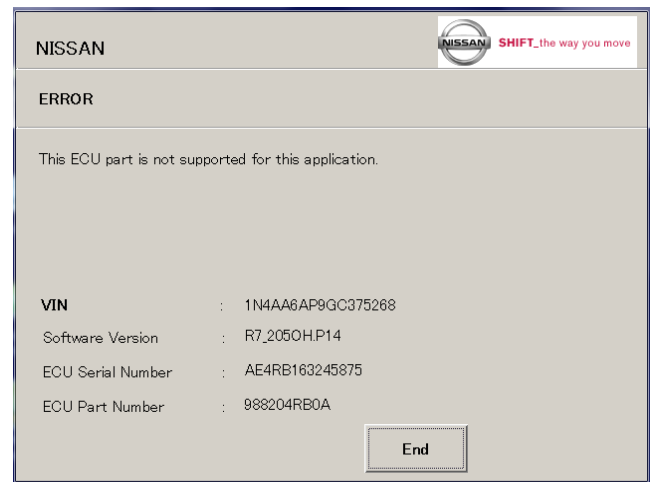
13. Is the screen in Figure 6 displayed?

- Select **End** and discontinue airbag reprogramming.
- Proceed to **OCS Control Unit Reprogram**.

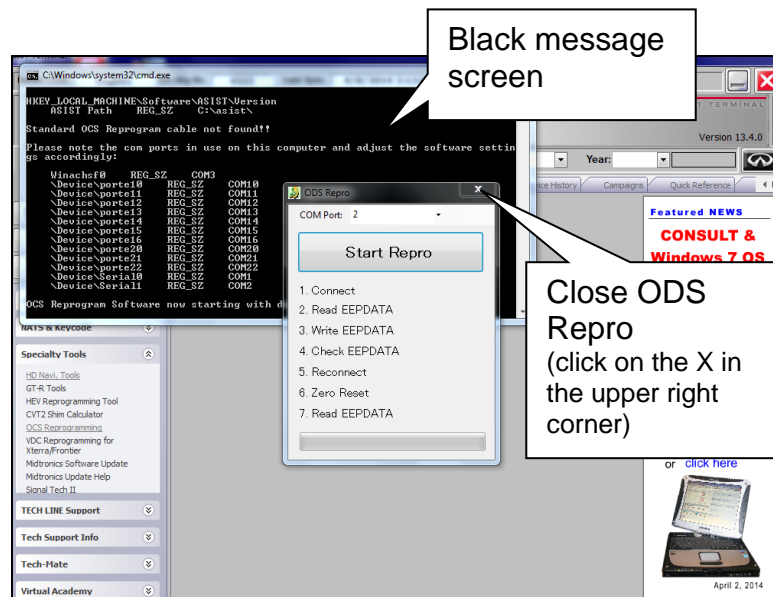
Figure 12

**NOTE:** If you get a black message screen as shown in Figure 12, this indicates that the reprogramming cable is not connected, or the cable driver did not install correctly.

- a. Close ODS Repro.
- b. Close ASIST.
- c. Start over from step 1 on page 8.

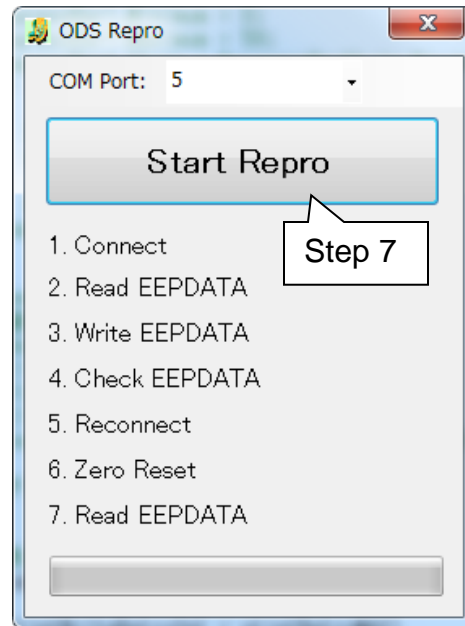
Figure 13

**NOTE:** If the error message “an error occurred on connection” displays:

- a. Disconnect the J-51594 OCS reprogramming cable, both ends.
- b. Reconnect the cable; make sure it is securely connected at both ends.
