Revised June 2016

Safety Recall S38 / NHTSA 16V-287

Left Front Halfshaft

2016 (KL) Jeep® Cherokee

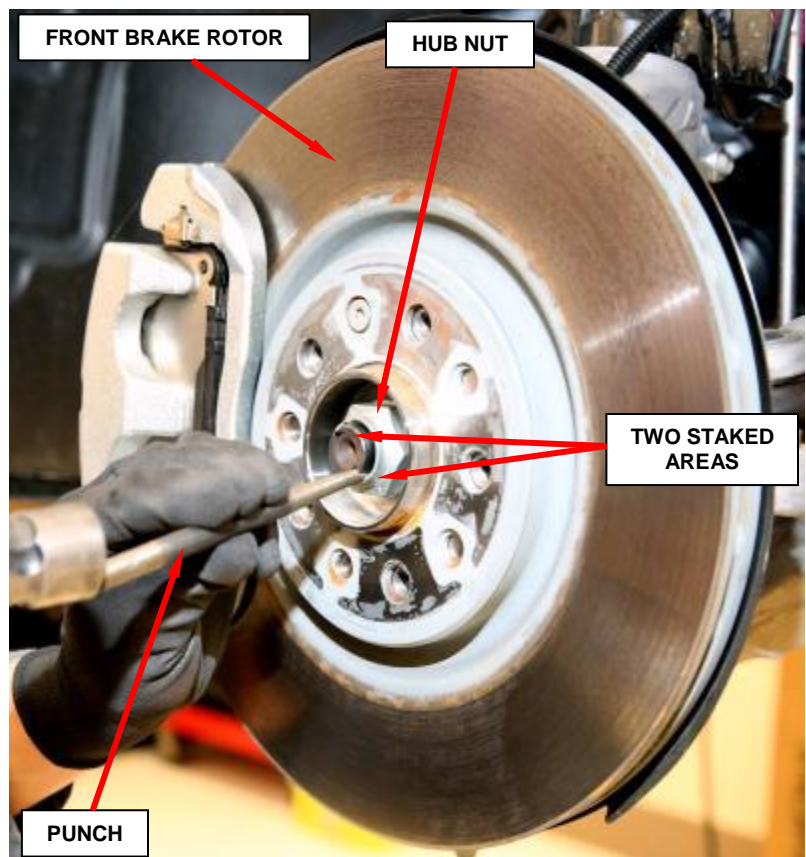
Figure 1 – Hub Nut

3. Using a suitable punch, lift the two staked areas in the hub nut to avoid damaging the halfshaft (Figure 1).

4. While a helper applies the brakes to keep the hub from rotating, remove and **discard** the hub nut from the halfshaft. **The original hub nut is not reusable (Figure 1).**

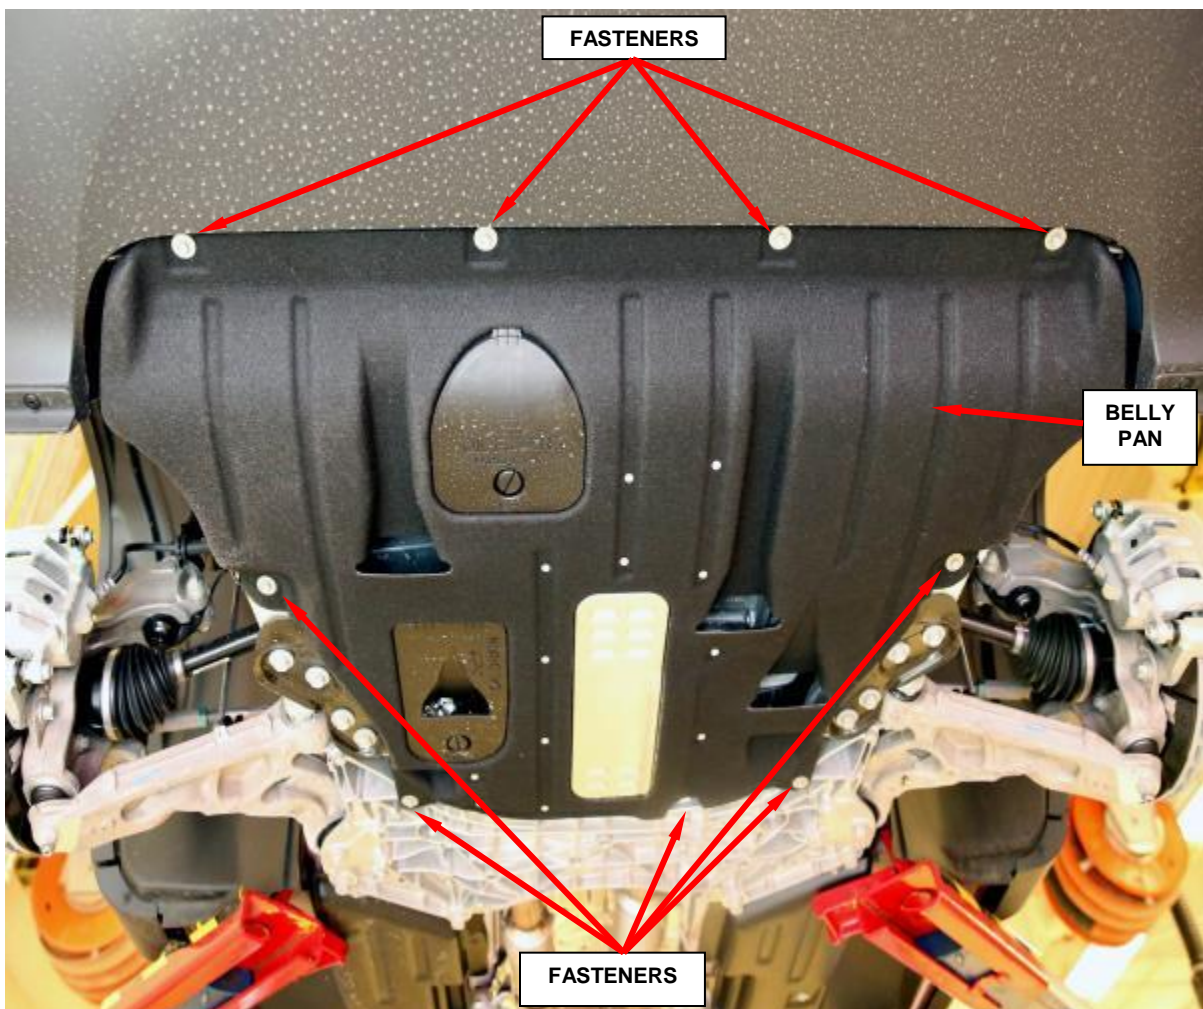
Figure 2 – Belly Pan

5. Remove and save the nine engine belly pan fasteners and remove the belly pan, if equipped (Figure 2).

19. If equipped, install the engine belly pan and tighten the fasteners securely (Figure 2).

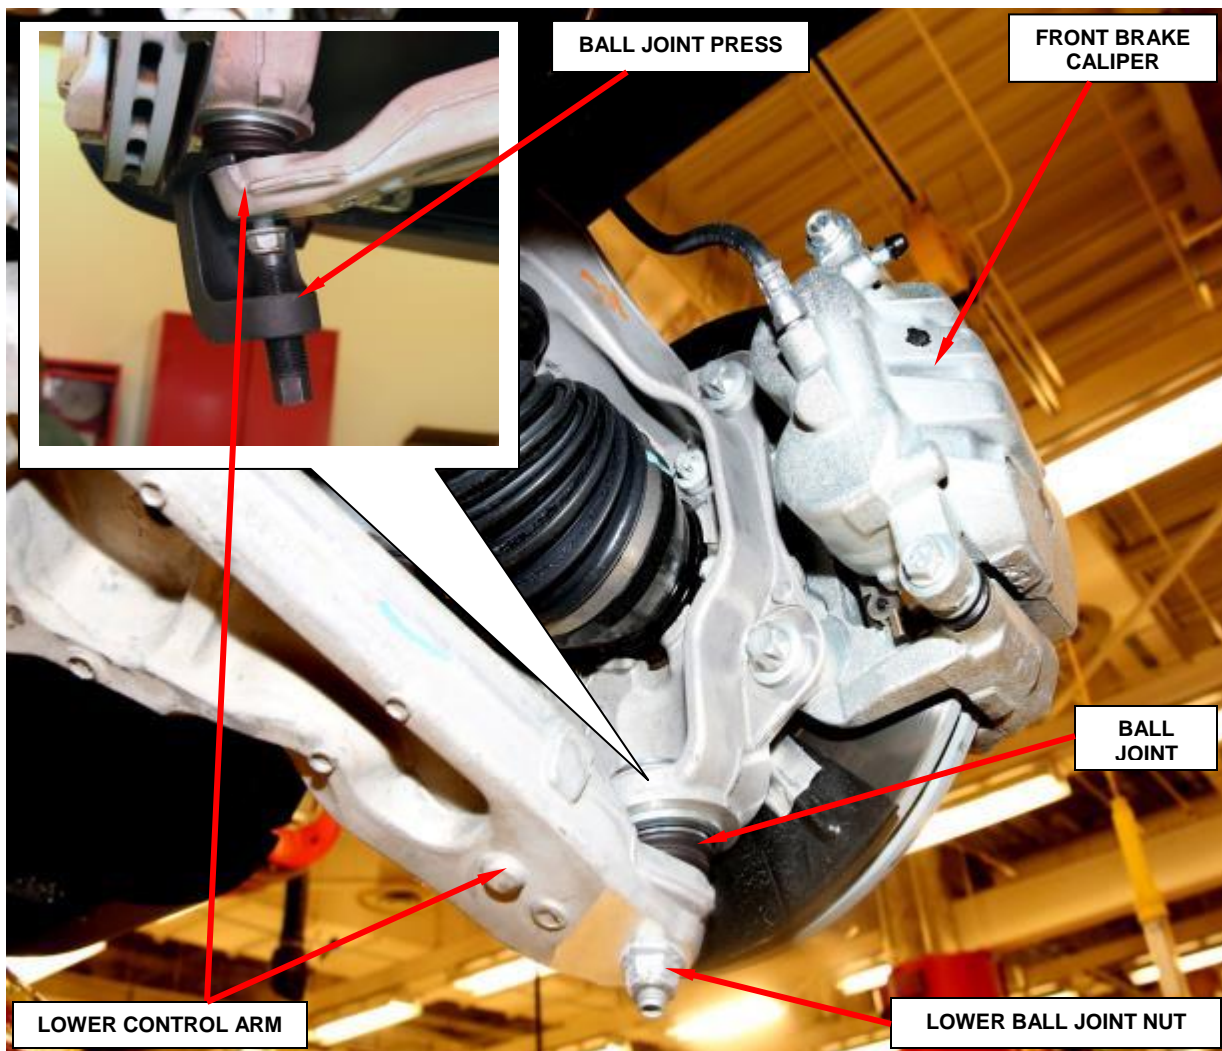
Figure 3 – Lower Ball Joint

6. Remove and **discard** the lower ball joint nut (Figure 3).

7. Using the Ball Joint Press C-4150A separate the ball joint stud from the lower control arm (Figure 3).

- Swing the steering knuckle outward and engage the halfshaft end into the hub bearing spline.
- Push the lower control arm downward until ball joint stud can enter the bottom of the knuckle.
- Insert the ball joint stud into the lower control arm.
- Install a **NEW** lower ball joint to control arm nut and tighten to 18 ft. lbs. Plus 175° (25 N•m Plus 175°) (Figure 3).

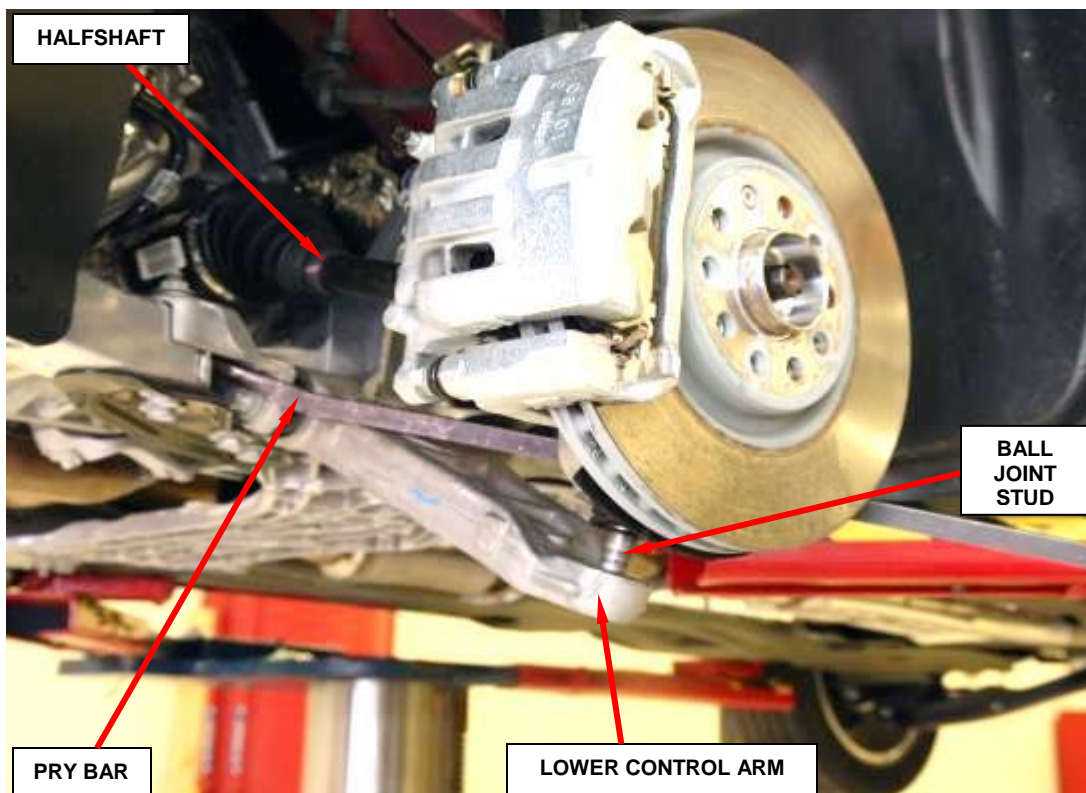
Figure 4 – Lower Control Arm

8. Insert a pry bar in the opening between the control arm front mounting bolt and the front fascia support beam (Figure 4).

9. Pry down on the control arm until the ball joint stud is clear of the control arm. Position the knuckle assembly to the side until it is clear of the ball joint stud. Slowly release the control arm.
10. Swing the steering knuckle outward and off the halfshaft end (Figure 4).

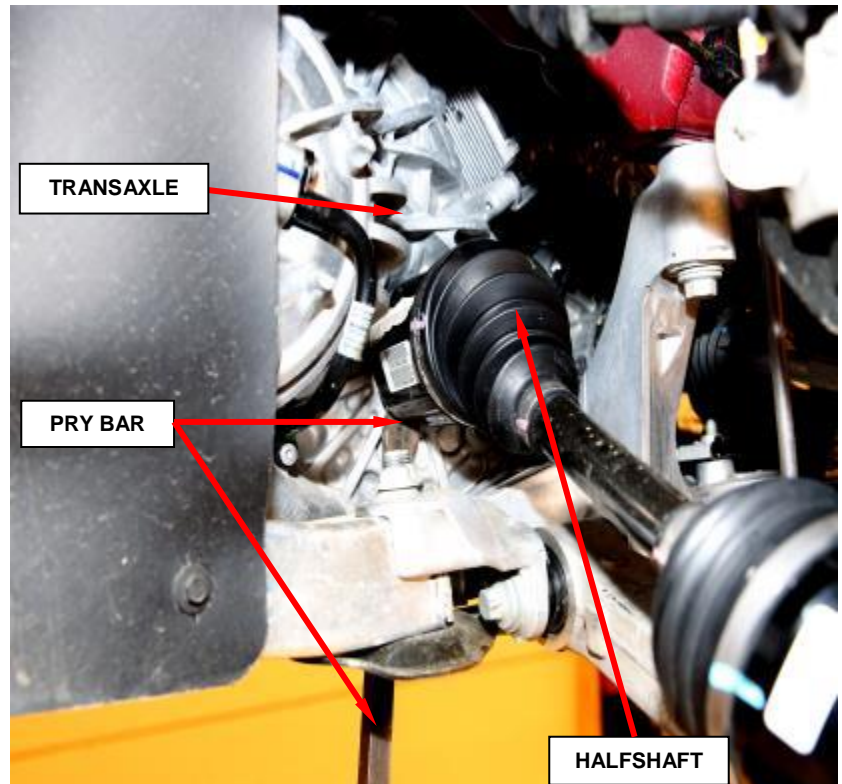
Figure 5 - Halfshaft to Transaxle

- Using a pry bar or equivalent tool release the halfshaft from the transaxle and remove the halfshaft from the vehicle (Figure 5).

- Install the halfshaft into the transaxle and lightly twist until halfshaft spline slides all the way into the transmission.

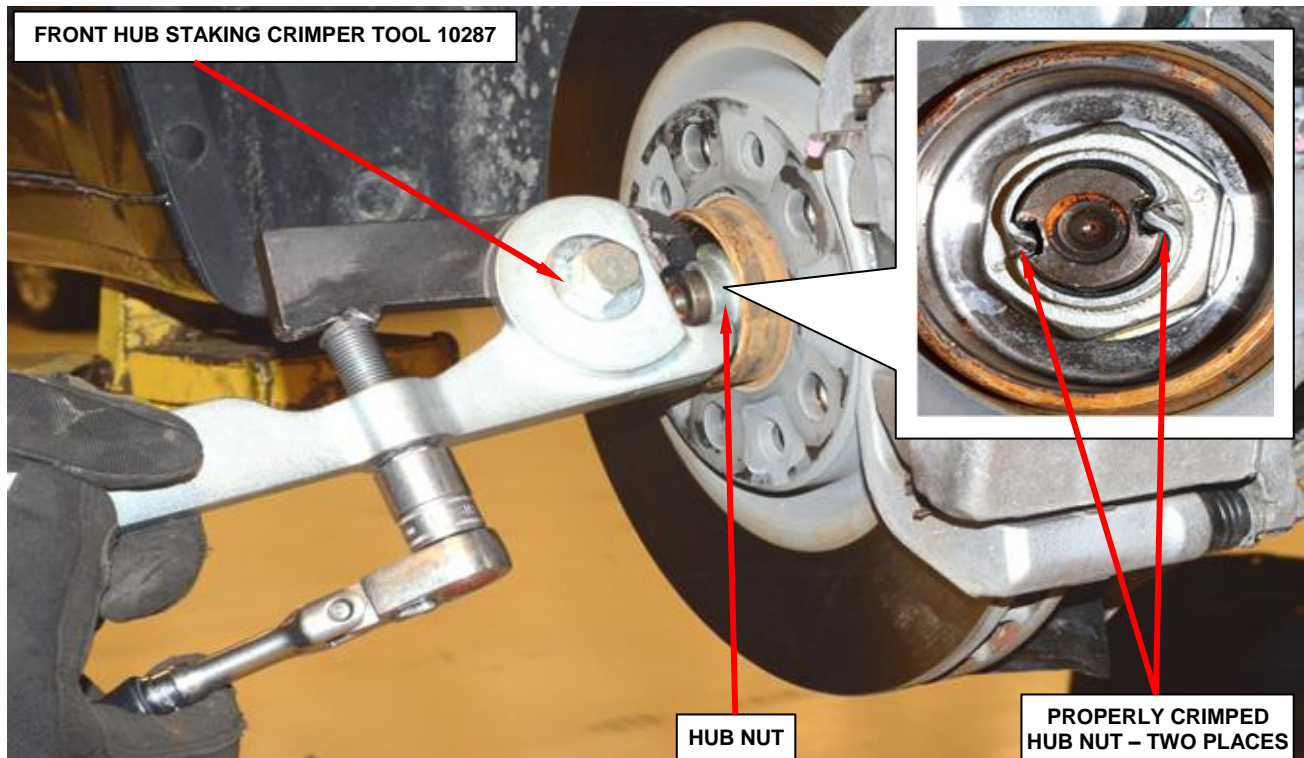
Figure 6 - Crimp Halfshaft Hub Nut with Special Tool 10287

18. Using the Tool, Front Hub Staking 10287, align the leading cutting edge of Tool, Front Hub Staking 10287 with the top left side channel on axle as shown. Tighten fastener on Tool, Front Hub Staking 10287 with hand tools until the threads bottom out completely (Figure 6).

NOTE: The hub nut must be staked so that it looks similar to Figure 6. Both edges must be split and bent into the shape shown. The staking must be opposite of the direction to tighten the nut.

17. Install a **NEW** hub nut and while a helper applies the brakes, tighten the nut to 148 ft. lbs. (200 N•m).
