REPAIR PROCEDURE

APPLICABILITY: 2016-2017 MY Legacy and Outback
SUBJECT: Inspection and Repair Procedure for Stop Sale / Recall Campaign
 WTD-65: Steering Column

NUMBER: WTD-65
DATE: 05/10/16

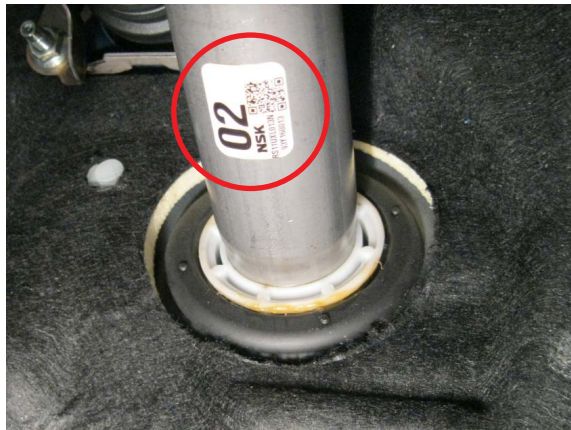
- Confirm the vehicle is within the provided VIN range.
- Locate the lot number label at the base of the steering column located just above the toe board grommet as shown in the photo below.

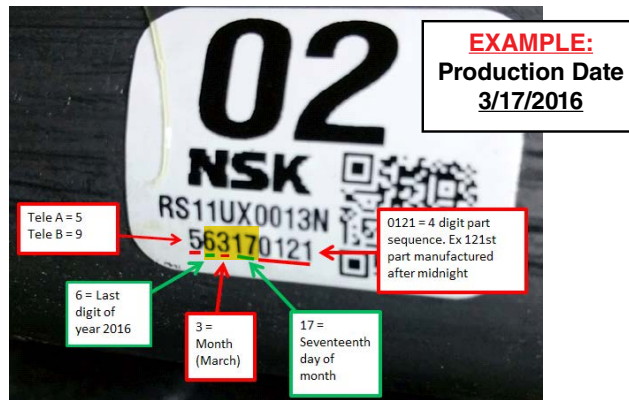
- Decode the lot number of the steering column using the illustration below.
- If the lot number on the steering column label is within the range between 6228 (February 28, 2016) and 6416 (April 16, 2016), the steering column assembly must be replaced.
- If the lot number is illegible or otherwise cannot be determined, it must be noted on the repair order and the steering column assembly must be replaced.

- **IMPORTANT:** Always record the lot number on the Repair Order even if it is outside the affected range.
