Revised July 2016

Dealer Service Instructions for:

Safety Recall S32 / NHTSA 16V-301 Front Halfshafts

2016 (DS) RAM 1500 Pickup

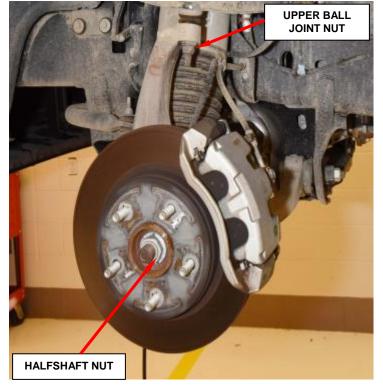
Figure 1 – Halfshaft Nut

- 1. Disconnect and isolate the negative battery cable.
- 2. With the vehicle in neutral, position the vehicle on a hoist and raise the vehicle to an appropriate height.
- 3. Remove the left front wheel and tire assembly.
- 4. Remove and **discard** the left half shaft nut from the shaft (Figure 1).

17. Install the **NEW** halfshaft nut and tighten to 185 ft. lbs. (251 N•m) (Figure 1).

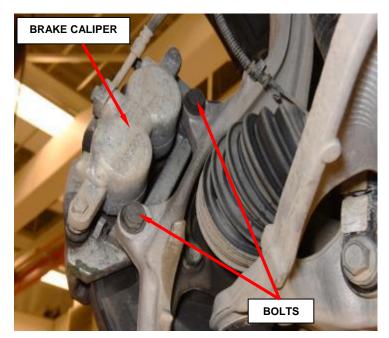
Figure 2 – Caliper Adaptor Bolts

- 5. Use the following steps to remove the left side steering knuckle.
 - a. Remove and **discard** the two left side caliper adaptor bolts from the steering knuckle, remove caliper adapter assembly, and hang aside (Figure 2).

- 14. Align the adapter and caliper to the steering knuckle, install the **NEW** adapter bolts and tighten to 130 ft. lbs. (176 N•m) (Figure 2).
- 15. Clip the wheel speed sensor wiring pigtail to the retaining clips (Figure 3).

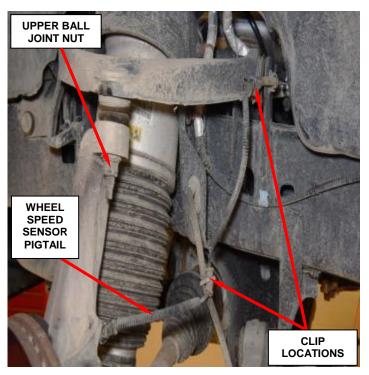
Figure 3 – Wheel Speed Sensor

- b. Using a paint marker or equivalent, mark the brake rotor position to the hub/bearing and remove the left side rotor from the hub/bearing.
- c. Disconnect the left side wheel speed sensor electrical connector from the engine harness.
- d. Release the left side wheel speed sensor wiring pigtail from the clips (Figure 3).
- e. Remove the wiring from the clips and disconnect the electrical connector.
- f. Remove and **discard** the left side tie rod end nut from the ball stud (Figure 4).
- g. Separate the left side tie rod ball stud from the knuckle with Ball Joint Remover 9360.
- h. Remove and **discard** the left side upper ball joint nut. Separate the ball joint from the knuckle with Ball Joint Remover 9360 (Figure 3).

- c. Tighten the upper ball joint nut to 40 ft. lbs. Plus 200° (54 N•m Plus 200°) (Figure 4).
 - d. Tighten the lower ball joint nut to 38 ft. lbs. Plus 90° (51 N•m Plus 90°) (Figure 5).

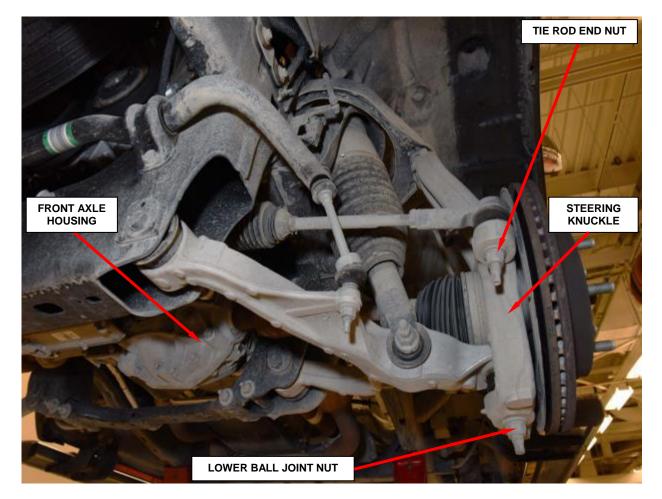
Figure 5 – Lower Ball Joint Nut

- i. Support the outboard side of the lower control arm to support vehicle weight.
- j. Remove and **discard** the lower ball joint nut. Separate the ball joint from the knuckle with Ball Joint Remover 8677 (Figure 5).
- k. Remove the steering knuckle from the vehicle (Figure 5).

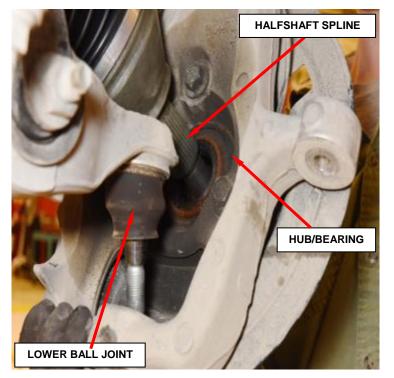
Figure 7 – Halfshaft to Knuckle

- 6. Disengage the inner C/V joint from the axle shaft with a pry bar between the C/V housing and axle housing (Figure 6).
- 7. Remove the left side halfshaft from vehicle and return the halfshaft for core charge reimbursement.
- 8. Install the left side halfshaft on axle shaft. Push inner C/V firmly PRY BAR axle shaft snap ring into the inner C/V housing.
 Figure 6 C/V Joint
- 9. Clean hub bearing bore, hub bearing mating surface and halfshaft splines.
- 10. Apply a light coating of grease to the front axle shaft output splines.
- 11. Install the left side halfshaft spline into the knuckle hub/bearing (Figure 7).
