SAFETY RECALL BULLETIN

NHTSA RECALL 16V-316

AUTOCAR, LLC SAFETY RECALL ACX-1602

Autocar has determined that a safety defect could exist in the wheel ends of certain 2016-2017 model year Xpeditors. The tab lock washers on the rear axle wheel ends may not have been properly bent over the outer spindle nut during assembly.

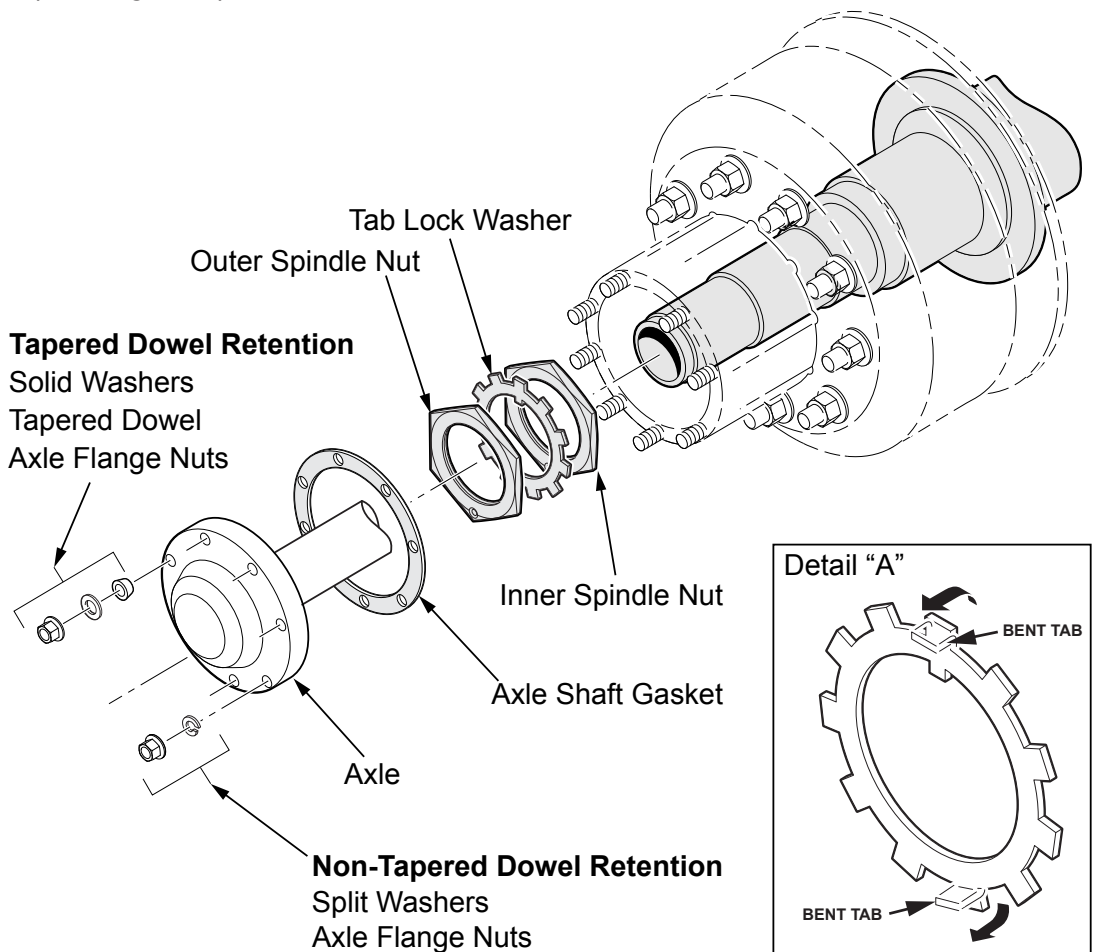
Figure 1

1. Remove the axle flange nuts, washers and axle and set aside for reinstallation (see Figure 1).
2. Remove the axle shaft gasket and discard (see Figure 1).
3. Inspect the tab lock washer to ensure that the tabs are properly bent over the outer spindle nut (tabs bent 180 degrees across from each other) (see Detail A).

4. Raise the wheel end and support with an appropriate jack stand.
5. Release the park brake.
6. Remove the outer spindle nut and tab lock washer and set aside for reinstallation (see Figure 1).
7. Tighten the inner spindle nut to 200 ft-lb of torque (see Figure 1).
8. Using a counterclockwise motion, back off the inner spindle nut one turn.
9. While rotating the wheel end assembly, tighten the inner spindle nut to 50 ft-lb of torque.
10. Using a counterclockwise motion, back off the inner spindle nut 1/6 (one flat) turn.
11. Reinstall the tab lock washer that was set aside in step 6.
12. Reinstall the outer spindle nut that was set aside in step 6 and tighten to 250 ft-lb of torque.

13. Using a dial indicator on the outer spindle nut, check the wheel end run out to verify wheel end play is between .001" and .005".

14. Bend two tabs on the tab lock washer outward 180 degrees across from each other over the outer spindle nut (see Detail A).
15. Clean the hub and axle flange of all residual gasket material.
16. Install the new axle shaft gasket (3973009-006) (see Figure 1).
17. Reinstall the axle and secure with the axle flange nuts and washers that were set aside in step 1.
18. Tighten the axle flange nuts to 190 ft-lb of torque if equipped with non-tapered dowel retention or 85-115 ft-lb of torque if equipped with tapered dowel retention (see Figure 1).
19. Set the park brake and lower the wheel end.
20. Repairs are completed.
