SAFETY RECALL BULLETIN

NHTSA RECALL 16V-319, Transport Canada 2016-235

AUTOCAR INDUSTRIES, LLC SAFETY RECALL MDTT-1601

June, 2016

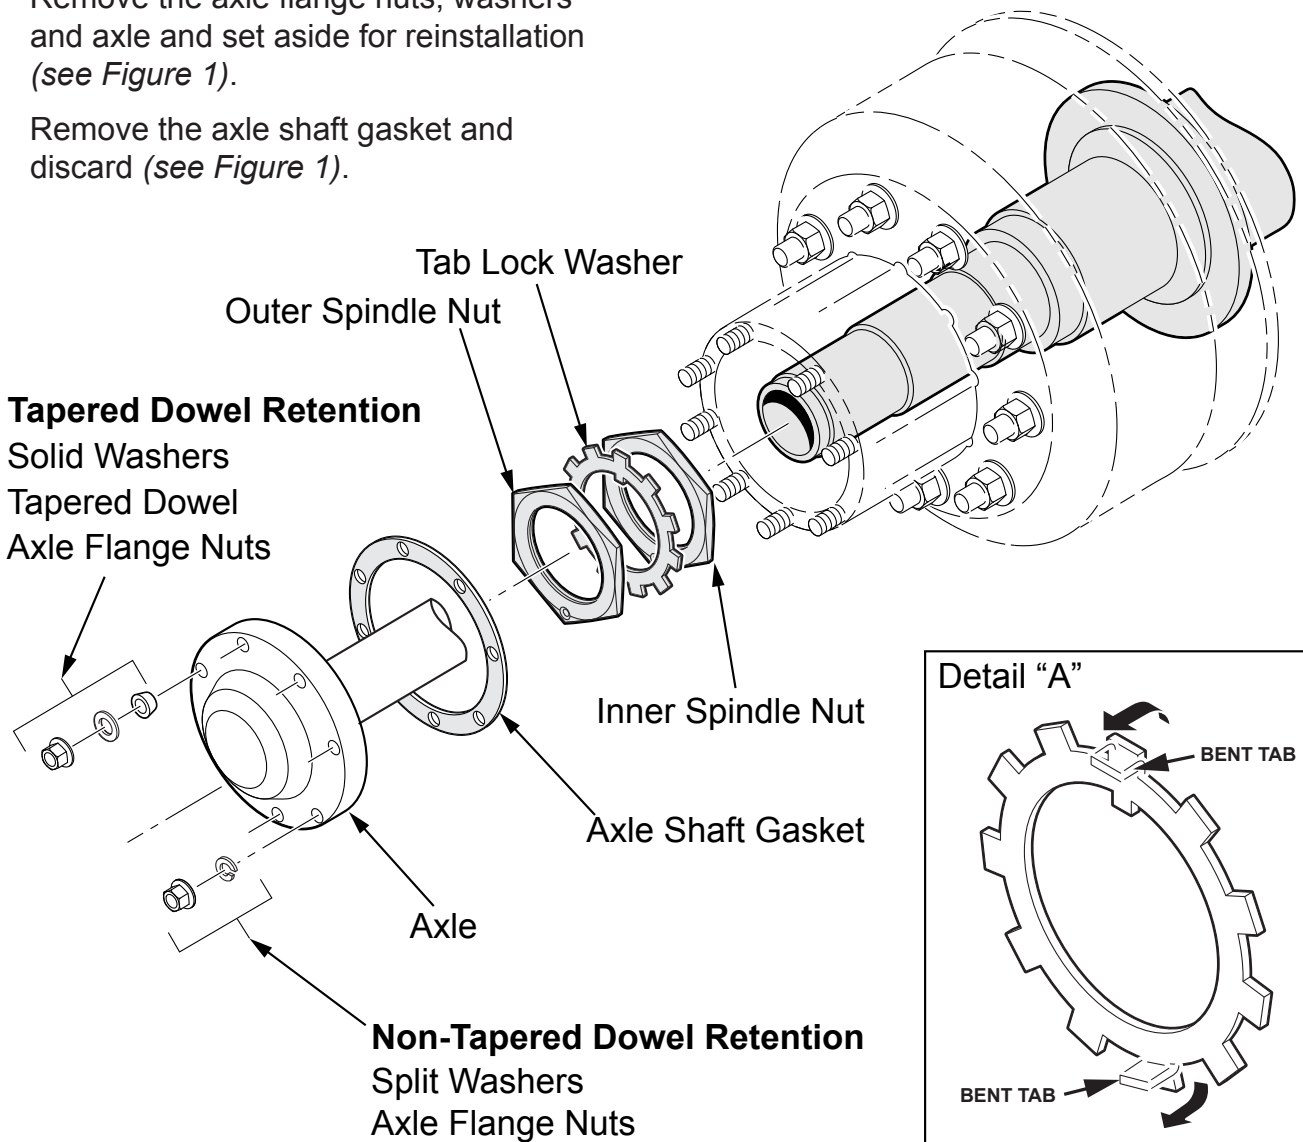
Figure 1

Autocar has determined that a safety defect could exist in the wheel ends of certain 2016-2017 model year Xspotter trucks and 2017 model year Xpert trucks. The tab lock washers on the rear axle wheel ends may not have been properly bent over the outer spindle nut during assembly.

1. Remove the axle flange nuts, washers and axle and set aside for reinstallation (see Figure 1).
2. Remove the axle shaft gasket and discard (see Figure 1).
3. Inspect the tab lock washer to ensure that the tabs are properly bent over the outer spindle nut (tabs bent 180 degrees across from each other) (see Detail A).

4. Raise the wheel end and support with an appropriate jack stand.
5. Release the park brake.
6. Remove the outer spindle nut and tab lock washer and set aside for reinstallation (see Figure 1).
7. Tighten the inner spindle nut to 200 ft-lb of torque (see Figure 1).
8. Using a counterclockwise motion, back off the inner spindle nut one turn.
9. While rotating the wheel end assembly, tighten the inner spindle nut to 50 ft-lb of torque.
10. Using a counterclockwise motion, back off the inner spindle nut 1/6 (one flat) turn.
11. Reinstall the tab lock washer that was set aside in step 6.
12. Reinstall the outer spindle nut that was set aside in step 6 and tighten to 250 ft-lb of torque.

13. Using a dial indicator on the outer spindle nut, check the wheel end run out to verify wheel end play is between .001" and .005".

14. Bend two tabs on the tab lock washer outward 180 degrees across from each other over the outer spindle nut (see Detail A).
15. Clean the hub and axle flange of all residual gasket material.
16. Install the new axle shaft gasket (3973009-006) (see Figure 1).
17. Reinstall the axle and secure with the axle flange nuts and washers that were set aside in step 1.
18. Tighten the axle flange nuts to 190 ft-lb of torque if equipped with non-tapered dowel retention or 85-115 ft-lb of torque if equipped with tapered dowel retention (see Figure 1).
19. Set the park brake and lower the wheel end.
20. Repairs are completed.
