# Thor Motor Coach Recall Repair Instructions

Recall #	16V-329		
Description/Title:	<b>2017 Venetian, Tuscany, Tuscany XTE Power Loss</b>		
Affected Product Line(s):	<b>Certain 2017 Venetian, Tuscany and Tuscany TXE Units</b>		
Service Campaign # :	<b>RC000114</b>	Released Date:	<b>6.25.16</b>
Failure Code:	<b>TMCRC80449V</b>	Document Date:	<b>6.25.16</b>
Time Allowed:	<b>0.3 hr</b>	Document Revision:	<b>A</b>

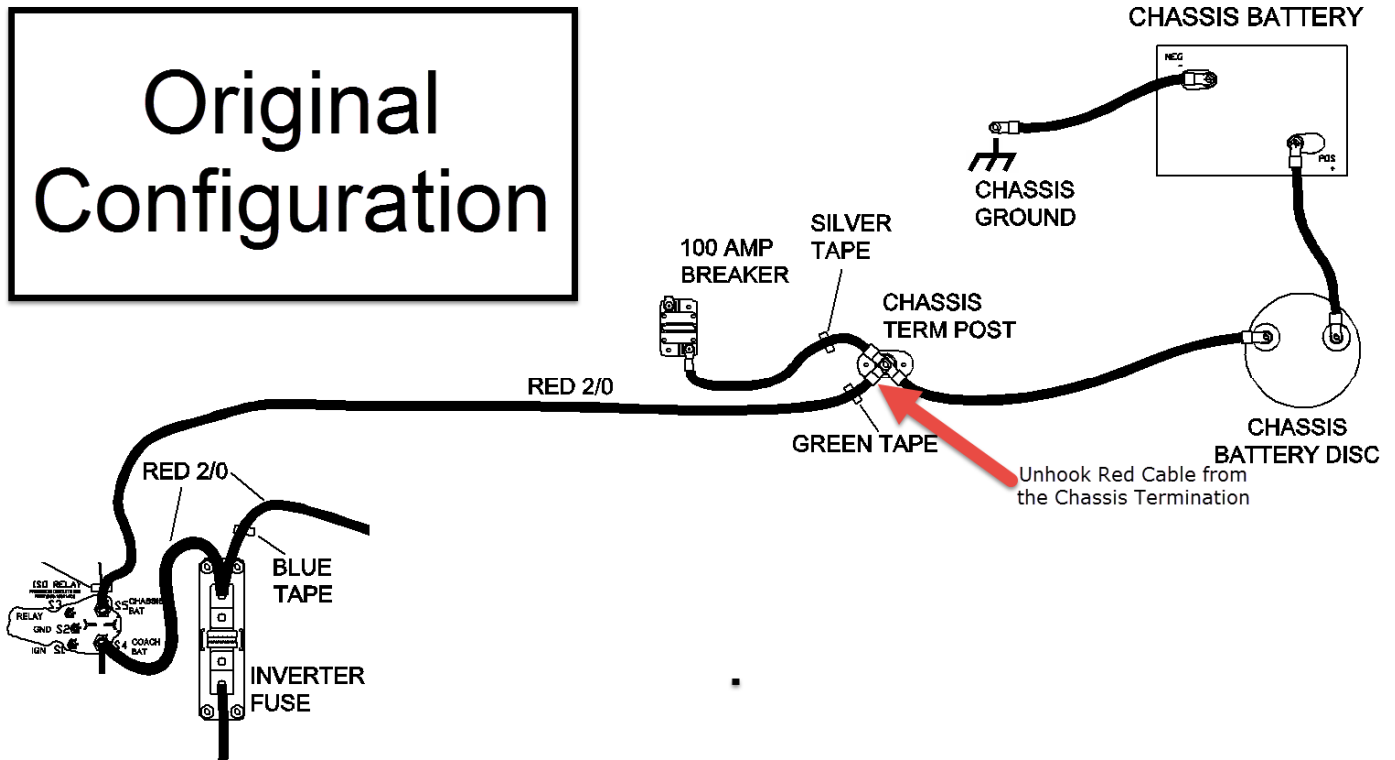
It has been decided that certain TMC Tuscany and Venetian model motorhomes subject to this recall campaign have the isolator relay cable for the chassis battery incorrectly installed. This could cause a sudden unexpected loss of power with the motorhome. If the motorhome is travelling on the road and a loss power occurs, the vehicle operator could experience loss of vehicle control which could result in an accident.

1. Unhook the Red Cable coming from the Isolator Relay.
