SIB 41 01 16

RECALL CAMPAIGN 16V-333: ISOFIX CHILD RESTRAINT SYSTEM ANCHORS

F25 (X3) F26 (X4)

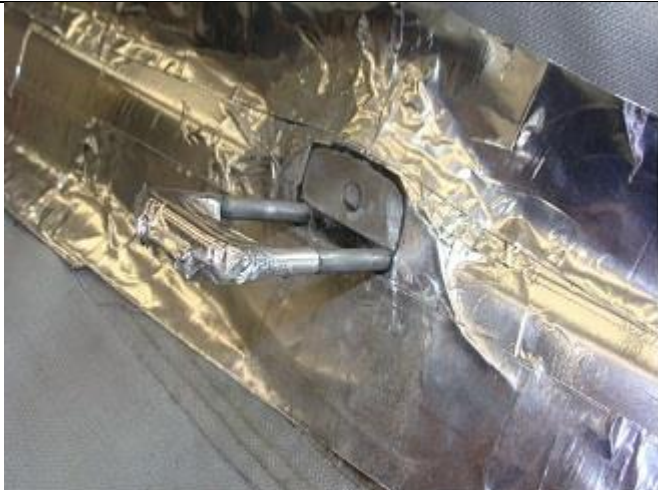
<p>13. Prepare ISOFIX anchor for welding. Note: Area at left is example of properly prepared area. Paint on end of anchor is intact.</p>

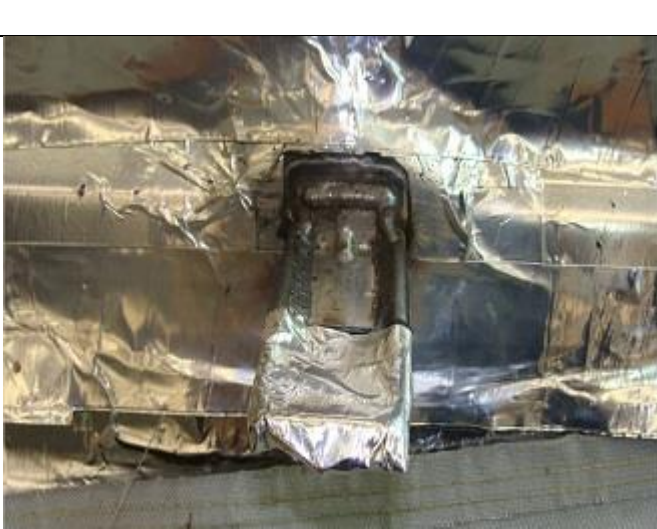
<p>18. Example of properly executed weld is shown. Notice, the welding bead is continuous from left to right side.</p>
