Recall Campaign 16V-XXX: ISOFIX Child Restraint System Anchors

This Service Information bulletin supersedes SI B41 01 16 dated May 2016.

F25 (X3)	F26 (X4)

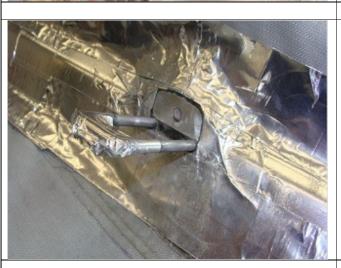
13. Prepare ISOFIX anchor for welding. Note: Area at left is example of properly prepared area. Paint on end of anchor is intact.

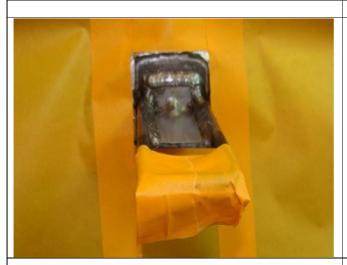
18. Example of properly executed weld is shown. Notice, the welding bead is continuous from left to right side.

19. Once the welds have sufficiently cooled, prepare the areas to reapply anti-corrosion protection.

Use a stainless steel brush to clean the weld before applying anti-corrosion protection.
