RECALL CAMPAIGN 16V-333: ISOFIX CHILD RESTRAINT SYSTEM ANCHORS

This Service Information bulletin supersedes SI B41 01 16 **dated November 2016**.

F25 (X3)	F26 (X4)
----------	----------

ISOFIX Recall SI B41 01 16

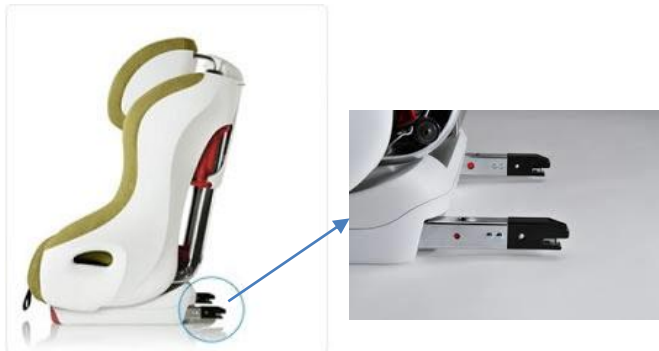
When specifically used with ISOFIX-type rigid-style connector child restraint systems, the lower anchor bars could become damaged over the lifetime of the vehicle. This rigid-style connector is mainly used in Europe but it is available in the US.

See the image below illustrating the rigid-style connectors.

This issue is unlikely to occur using LATCH-type flexible-style connector child restraint systems which represent the majority of child restraint systems used in the US.

A reinforcing bracket will be welded to the lower anchor bars and the vehicle body.
