SI B41 01 16
Body Equipment

RECALL CAMPAIGN 16V-333: ISOFIX CHILD RESTRAINT SYSTEM ANCHORS

F25 (X3)	F26 (X4)
----------	----------

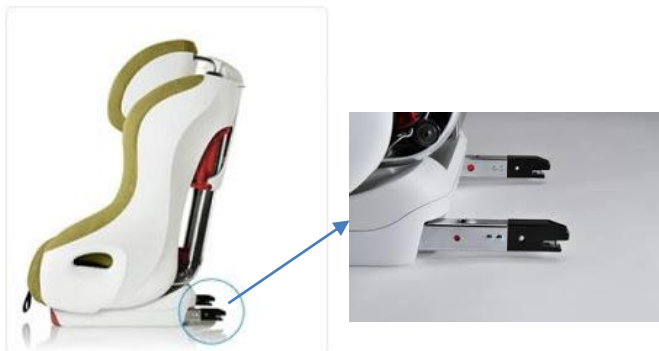
When specifically used with ISOFIX-type rigid-style connector child restraint systems, the lower anchor bars could become damaged over the lifetime of the vehicle. This rigid-style connector is mainly used in Europe but it is available in the US.

See the image below illustrating the rigid-style connectors.

A reinforcing bracket will be welded to the lower anchor bars and the vehicle body.
