SI B41 01 16
Body

Recall Campaign 16V-XXX: ISOFIX Child Restraint System Anchors

F25 (X3)	F26 (X4)
----------	----------

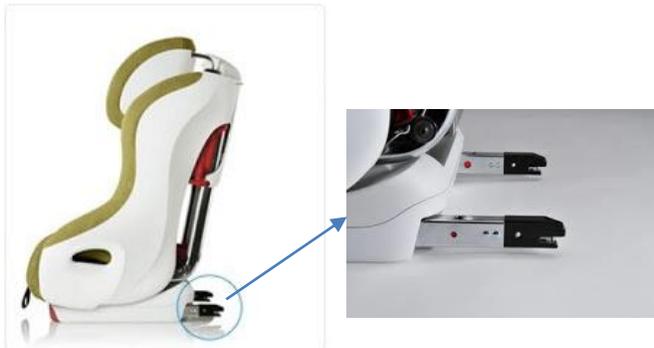
When specifically used with ISOFIX-type rigid-style connector child restraint systems, the lower anchor bars could become damaged over the lifetime of the vehicle. This rigid-style connector is mainly used in Europe but it is available in the US.

See the image below illustrating the rigid-style connectors.
