HYUNDAI | NEW THINKING.
NEW POSSIBILITIES.

Technical Service Bulletin

GROUP CAMPAIGN	NUMBER 16-01-028-1
DATE JUNE 2016	MODEL(S) 2016 TUCSON (TL)

SUBJECT: HOOD SAFETY HOOK CATCH REPLACEMENT
AND CLUSTER UPDATE (RECALL 145)

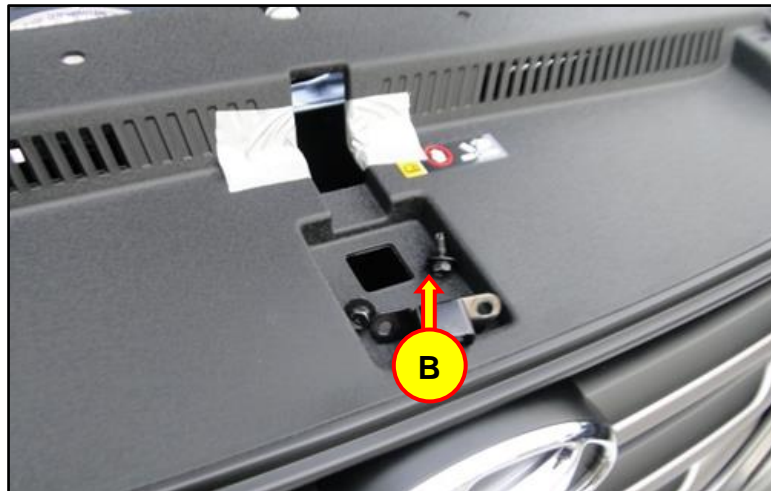
Description: On some 2016 Tucson (TL) vehicles, due to a tolerance build-up between the secondary hood latch and catch mechanisms, the secondary hood latch can potentially disengage from the catch while driving **if the primary hood latch is released**. The condition may result in obscuring the driver's vision or increase the risk of crash.

8. Remove the hood safety hook catch (B) and install the replacement hood safety hook catch. Reinstall all the removed parts in reverse order of removal. Remove the masking tape.
