**PRODUCT CAMPAIGN BULLETIN**

<p><b>APPLICABILITY:</b> 2003-2006 model year Baja          2003-2004 model year Legacy          2003-2004 model year Outback          2009-2011 model year Legacy          2009-2011 model year Outback          2009-2011 model year Forester          2006-2011 model year Tribeca          2006-2011 model year Impreza (including WRX and STI)</p>	<p><b>NUMBERS:</b> TKA-16R          TKB-16R          TKC-16R  <b>DATE:</b> 07/13/16  <b>REVISED:</b> 12/07/17  <b>NHTSA ID:</b> 16V-358          16V-359          16V-361</p>
---	---

**SUBJECT:** Takata Front Passenger Airbag Inflator Replacement

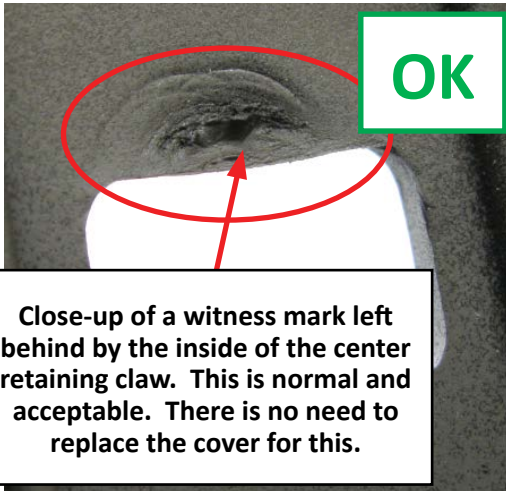
Close-up of a witness mark left behind by the inside of the center retaining claw. This is normal and acceptable. There is no need to replace the cover for this.

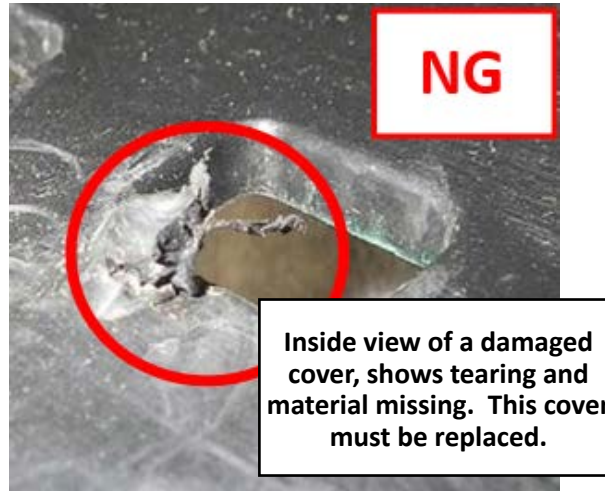
Inside view of a damaged cover, shows tearing and material missing. This cover must be replaced.

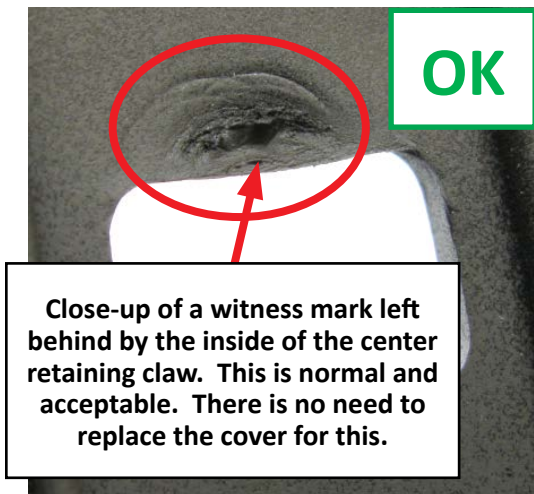
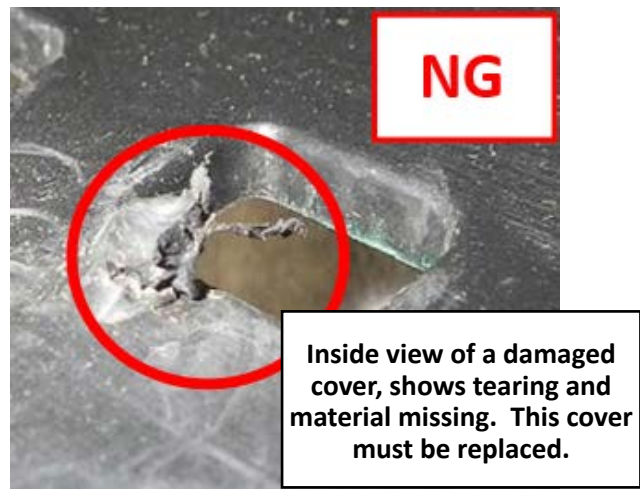
- Inspect the claw openings on the outside and inside of the cover for damage. If any found to look like the NG example photo below, the cover must be replaced.
