**SUBARU**

## PRODUCT CAMPAIGN BULLETIN

**NUMBERS:** TKA-16R  
 TKB-16R  
 TKC-16R  
**DATE:** 07/13/16  
**REVISED:** 10/31/16  
**NHTSA ID:** 16V-358  
 16V-359  
 16V-361

**SUBJECT:** Takata Front Passenger Airbag Inflator Replacement

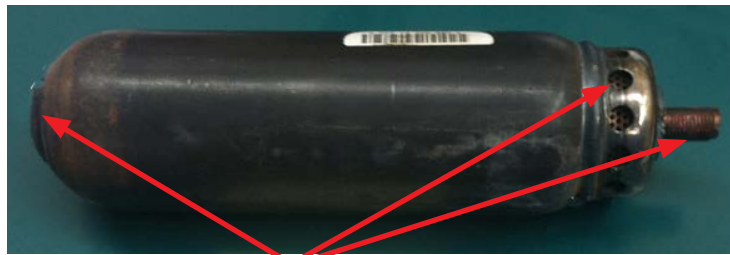
**The shape, holes, and copper-colored stud indicate this not a Genuine Subaru inflator.**

- **Do not proceed with this repair if your inspection reveals a non-Genuine Subaru air bag module has been installed in the vehicle.** Follow the instructions described in the “Counterfeit Air Bag Information” Dealer Advisory Bulletin.

- Document the presence of the aftermarket or counterfeit device on the repair order and with photos. Report this information immediately on a Quality Monitoring Report (QMR).
