**PRODUCT CAMPAIGN BULLETIN**

<p><b>APPLICABILITY:</b> 2003-2006 model year Baja          2003-2004 model year Legacy          2003-2004 model year Outback          2009-2011 model year Legacy          2009-2011 model year Outback          2009-2011 model year Forester          2006-2011 model year Tribeca          2006-2011 model year Impreza (including WRX and STI)</p>	<p><b>NUMBERS:</b> TKA-16R          TKB-16R          TKC-16R  <b>DATE:</b> 07/13/16  <b>REVISED:</b> 09/07/16  <b>NHTSA ID:</b> 16V-358          16V-359          16V-361</p>
---	---

**SUBJECT:** Takata Front Passenger Airbag Inflator Replacement

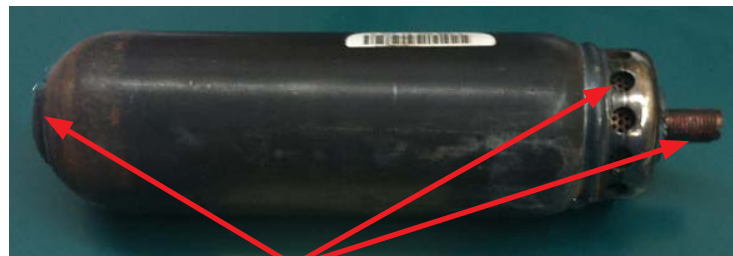
**The shape, holes, and copper-colored stud indicate this not a Genuine Subaru inflator.**

- **Do not proceed with this repair if your inspection reveals a non-Genuine Subaru air bag module has been installed in the vehicle.** Follow the instructions described in the “Counterfeit Air Bag Information” Dealer Advisory Bulletin.

- Document the presence of the aftermarket or counterfeit device on the repair order and with photos. Report this information immediately on a Quality Monitoring Report (QMR).
