PRODUCT CAMPAIGN BULLETIN

<p>APPLICABILITY: 2003-2006 model year Baja 2003-2004 model year Legacy 2003-2004 model year Outback 2009-2011 model year Legacy 2009-2011 model year Outback 2009-2011 model year Forester 2006-2011 model year Tribeca 2006-2011 model year Impreza (including WRX and STI)</p>	<p>NUMBERS: TKA-16R TKB-16R TKC-16R</p> <p>DATE: 07/13/16</p> <p style="background-color: #f1c40f;">REVISED: 12/21/22</p> <p>NHTSA ID: 16V-358 16V-359 16V-361</p>
---	--

SUBJECT: Takata Front Passenger Airbag Inflator Replacement

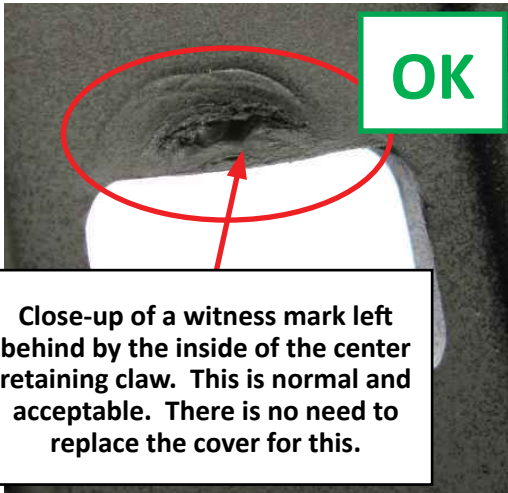
Close-up of a witness mark left behind by the inside of the center retaining claw. This is normal and acceptable. There is no need to replace the cover for this.

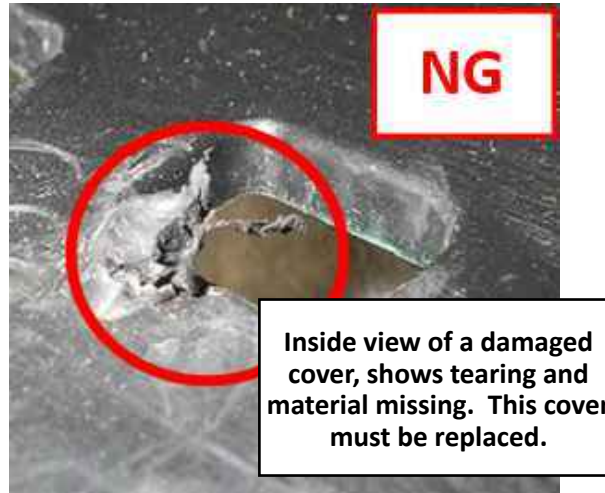
Inside view of a damaged cover, shows tearing and material missing. This cover must be replaced.
