Product Safety Recall

15044 Front Passenger Air Bag Inflator

Release Date: January 2019

Condition	It has been determined that a defect, which relates to motor vehicle safety, exists in all 2006 model year Saab 9-2X vehicles currently registered or previously registered in Alabama, California, Florida, Georgia, Hawaii, Louisiana, Mississippi, South Carolina, Texas, Guam, Puerto Rico, Saipan, U.S. Samoa or U.S. Virgin Islands. In these vehicles, the front passenger air bag inflator may experience an alteration over time, which could lead to overaggressive combustion in the event of an air bag deployment. This condition could create excessive internal pressure when the air bag is deployed, which could result in the body of the inflator rupturing upon deployment. In the event of an inflator rupture, metal fragments could pass through the air bag cushion material, which may result in injury or death to vehicle occupants.
Correction	Dealers are to replace the front passenger air bag module assembly.

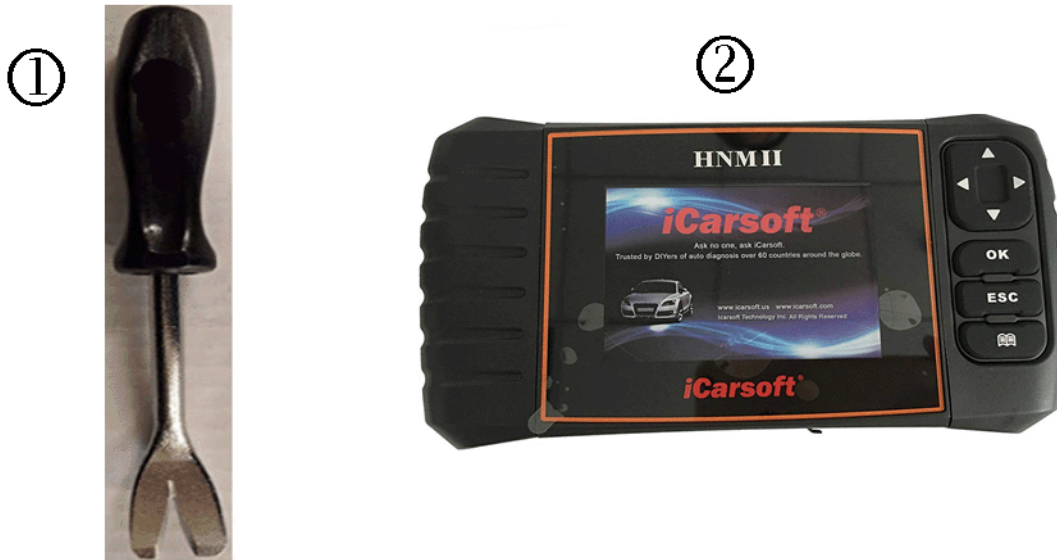
5145880

(1) Trim Clip Removal Tool (2) iCarsoft HNM II Diagnostic tool

This trim clip removal tool (1) must be used to properly perform the front passenger air bag module replacement procedure described in this bulletin. GM dealers should already have at least one of these trim clip removal tools in their special tool inventory.

This scan tool (2) must be used to properly perform the front passenger air bag module replacement procedure described in this bulletin. Dealers should purchase this scan tool either online or locally. **GM will reimburse for only one scan tool per dealer.** Tool description: iCarsoft HNM II Diagnostic tool with all systems diagnoses, OBDII full functions and reset services.

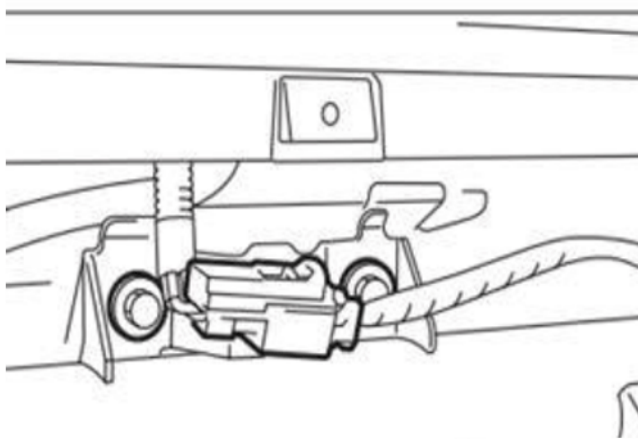
5145837

9. Disconnect the airbag module harness connector (A) and release it from the support beam bracket.

10. Remove the 3 retaining bolts and CAREFULLY remove the airbag module from the vehicle and place it on a clean cloth to protect the dash trim outer surface portion from damage.

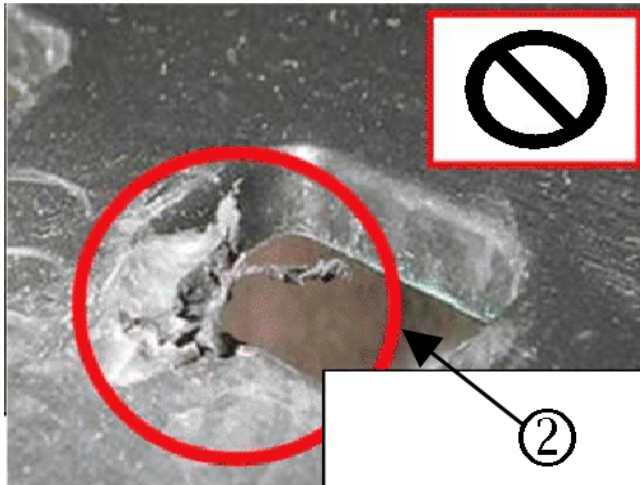
5145910

14. Inspect the claw openings on the outside and inside of the cover for damage. If any found to look like the (2) the cover must be replaced.
