SERVICE INFORMATION BULLETIN

NUMBER: 07-116-16R

SUBJECT: Supplemental Service Procedure Information to be Used in Conjunction with Campaigns WQP-51, WQR-53R, TKA, B, C-16R and **TKA, B, C-17R**

DATE: 11/11/16

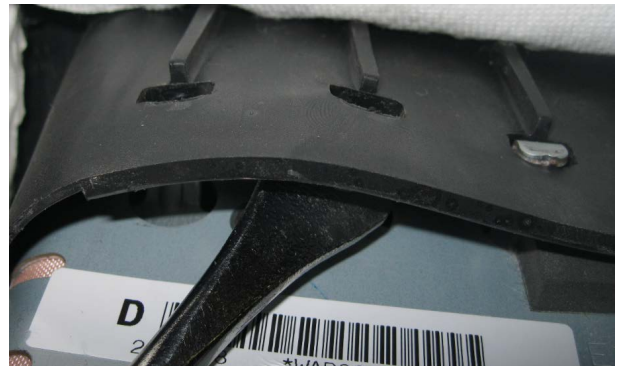
Retaining claws being CAREFULLY disengaged.

A trim clip removal tool makes disengaging the retaining claws easy. Insert the tool between the IP and module then **CAREFULLY** twist to disengage the claws.

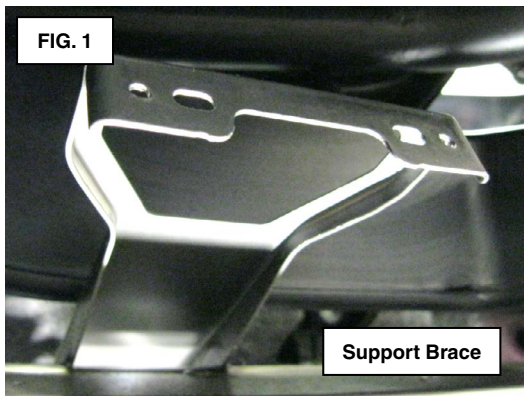
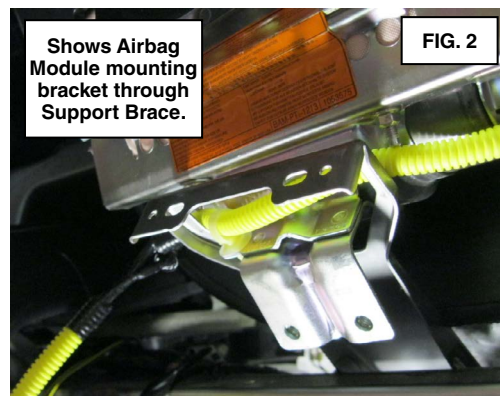
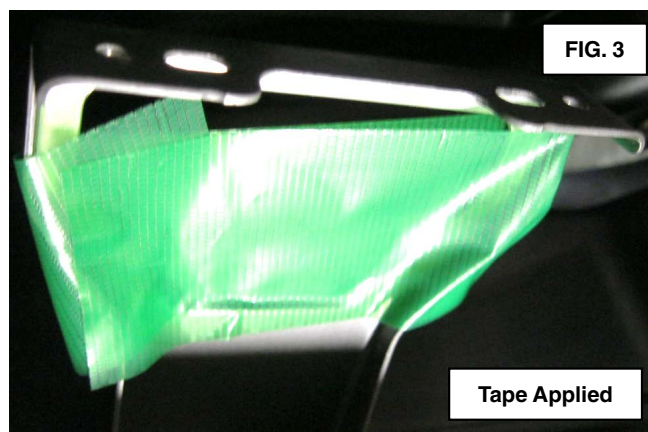
- On these models, there is an additional support brace for the IP attached to the steering column support bar (**Fig. 1** below). The bracket has an opening in it which the mounting bracket for the airbag module fits through easily. The airbag module cannot be removed if it's mounting bracket becomes caught in this brace (**Fig. 2**). **BEFORE** attempting to remove the airbag module, apply a piece of duct tape (or equivalent) to the brace (**Fig. 3**) to prevent this.
