PRODUCT CAMPAIGN BULLETIN

<p>APPLICABILITY: 2003-2006 model year Baja 2003-2004 model year Legacy 2003-2004 model year Outback 2009-2011 model year Legacy 2009-2011 model year Outback 2009-2011 model year Forester 2006-2011 model year Tribeca 2006-2011 model year Impreza (including WRX and STI)</p>	<p>NUMBERS: TKA-16R TKB-16R TKC-16R</p> <p>DATE: 07/13/16</p> <p style="background-color: yellow;">REVISED: 12/28/23</p> <p>NHTSA ID: 16V-358 16V-359 16V-361</p>
---	---

SUBJECT: Takata Front Passenger Airbag Inflator Replacement

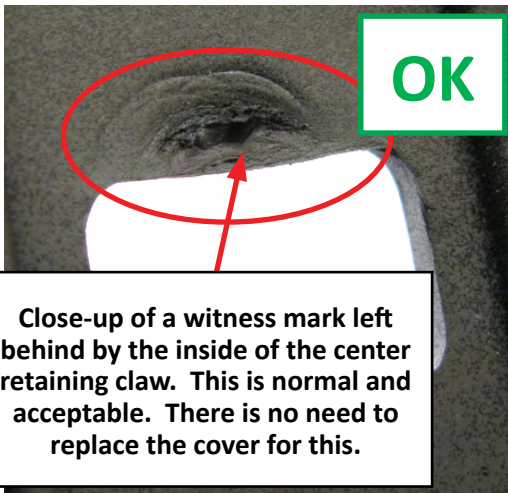
Close-up of a witness mark left behind by the inside of the center retaining claw. This is normal and acceptable. There is no need to replace the cover for this.

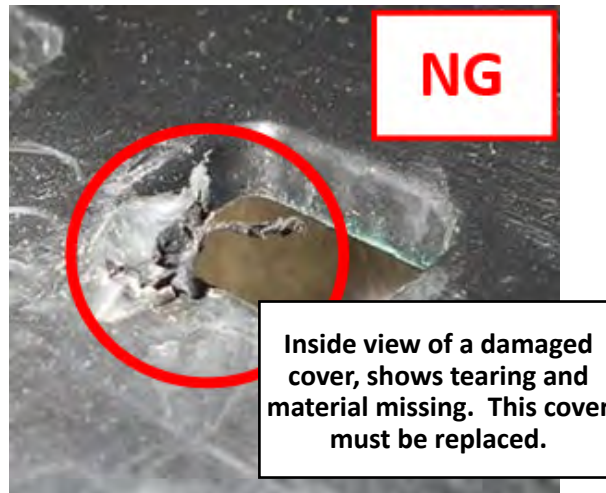
Inside view of a damaged cover, shows tearing and material missing. This cover must be replaced.
