PRODUCT CAMPAIGN BULLETIN

<p>APPLICABILITY: 2003-2006 model year Baja 2003-2004 model year Legacy 2003-2004 model year Outback 2009-2011 model year Legacy 2009-2011 model year Outback 2009-2011 model year Forester 2006-2011 model year Tribeca 2006-2011 model year Impreza (including WRX and STI)</p>	<p>NUMBERS: TKA-16R TKB-16R TKC-16R</p> <p>DATE: 07/13/16</p> <p style="background-color: #ffeb3b;">REVISED: 07/20/18</p> <p>NHTSA ID: 16V-358 16V-359 16V-361</p>
---	--

SUBJECT: Takata Front Passenger Airbag Inflator Replacement

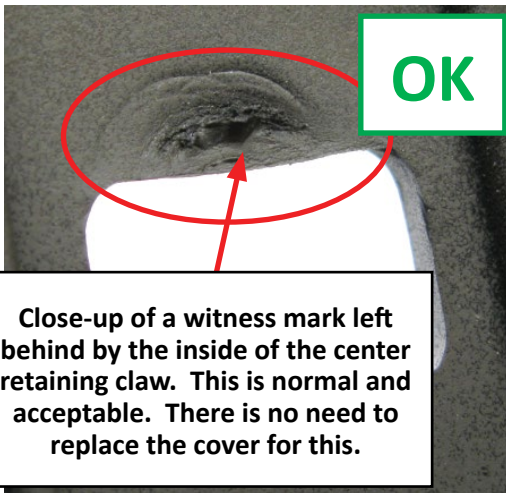
OK

Close-up of a witness mark left behind by the inside of the center retaining claw. This is normal and acceptable. There is no need to replace the cover for this.

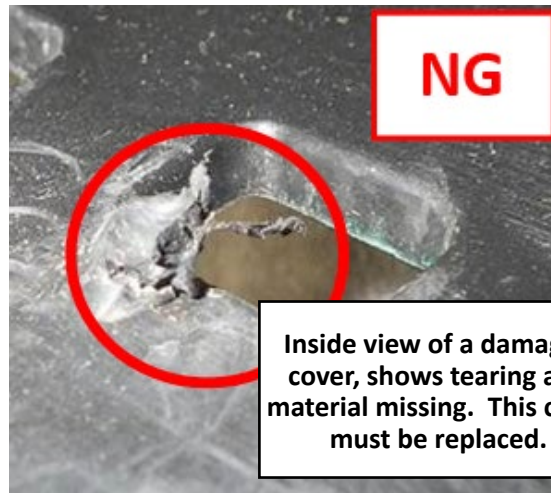
NG

Inside view of a damaged cover, shows tearing and material missing. This cover must be replaced.

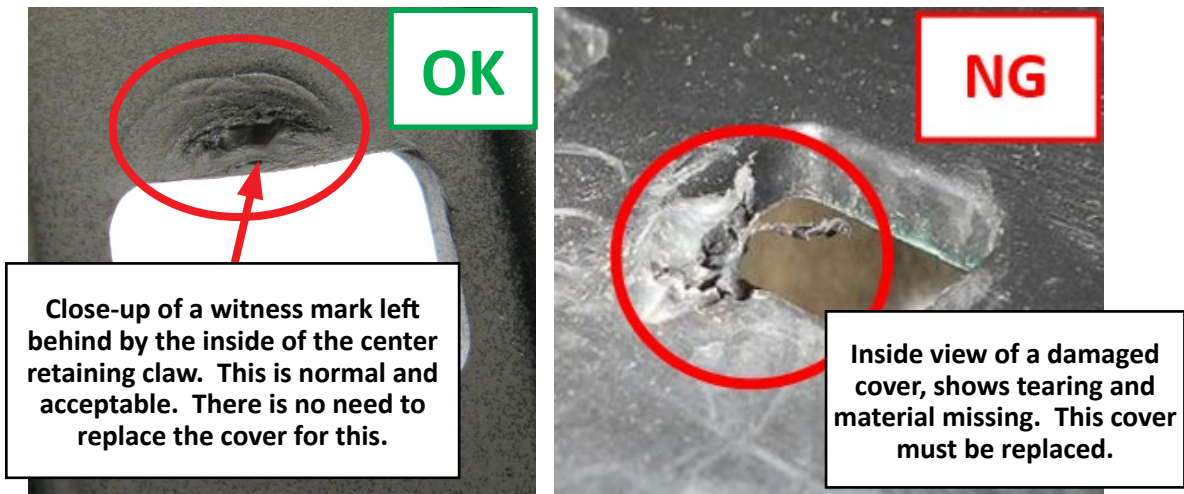
- Inspect the claw openings on the outside and inside of the cover for damage. If any found to look like the NG example photo below, the cover must be replaced.
