PRODUCT CAMPAIGN BULLETIN

<p>APPLICABILITY: 2003-2006 model year Baja 2003-2004 model year Legacy 2003-2004 model year Outback 2009-2011 model year Legacy 2009-2011 model year Outback 2009-2011 model year Forester 2006-2011 model year Tribeca 2006-2011 model year Impreza (including WRX and STI)</p>	<p>NUMBERS: TKA-16R TKB-16R TKC-16R</p> <p>DATE: 07/13/16</p> <p style="background-color: yellow;">REVISED: 05/11/17</p> <p>NHTSA ID: 16V-358 16V-359 16V-361</p>
---	---

SUBJECT: Takata Front Passenger Airbag Inflator Replacement

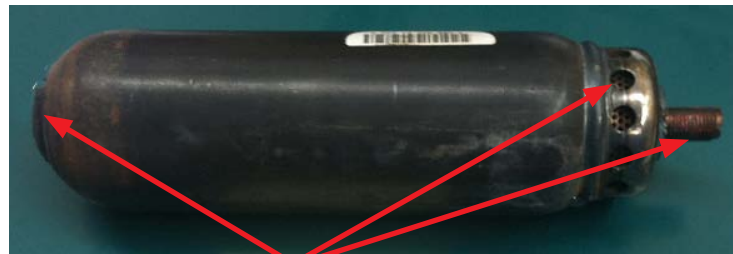
The shape, holes, and copper-colored stud indicate this not a Genuine Subaru inflator.

- **Do not proceed with this repair if your inspection reveals a non-Genuine Subaru air bag module has been installed in the vehicle.** Follow the instructions described in the “Counterfeit Air Bag Information” Dealer Advisory Bulletin.

- Document the presence of the aftermarket or counterfeit device on the repair order and with photos. Report this information immediately on a Quality Monitoring Report (QMR). **IMPORTANT: When entering a related QMR, use failure code ULF and NOT the campaign fail code.**
