## PRODUCT CAMPAIGN BULLETIN

**APPLICABILITY:** 2003-2006 model year Baja  
 2003-2004 model year Legacy  
 2003-2004 model year Outback  
 2009-2011 model year Legacy  
 2009-2011 model year Outback  
 2009-2011 model year Forester  
 2006-2011 model year Tribeca  
 2006-2011 model year Impreza (including WRX and STI)

**NUMBERS:** TKA-16R  
 TKB-16R  
 TKC-16R  
**DATE:** 07/13/16  
**REVISED:** 10/03/16  
**NHTSA ID:** 16V-358  
 16V-359  
 16V-361

**SUBJECT:** Takata Front Passenger Airbag Inflator Replacement

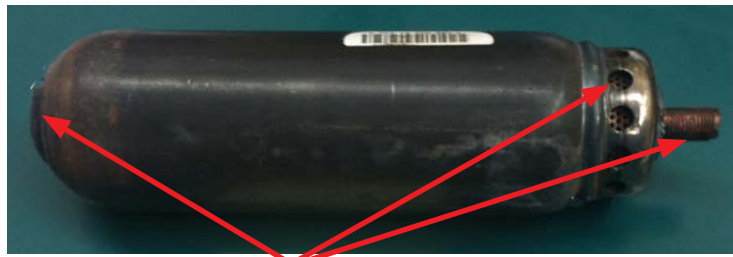
**The shape, holes, and copper-colored stud indicate this not a Genuine Subaru inflator.**

- **Do not proceed with this repair if your inspection reveals a non-Genuine Subaru air bag module has been installed in the vehicle.** Follow the instructions described in the “Counterfeit Air Bag Information” Dealer Advisory Bulletin.

- Document the presence of the aftermarket or counterfeit device on the repair order and with photos. Report this information immediately on a Quality Monitoring Report (QMR).

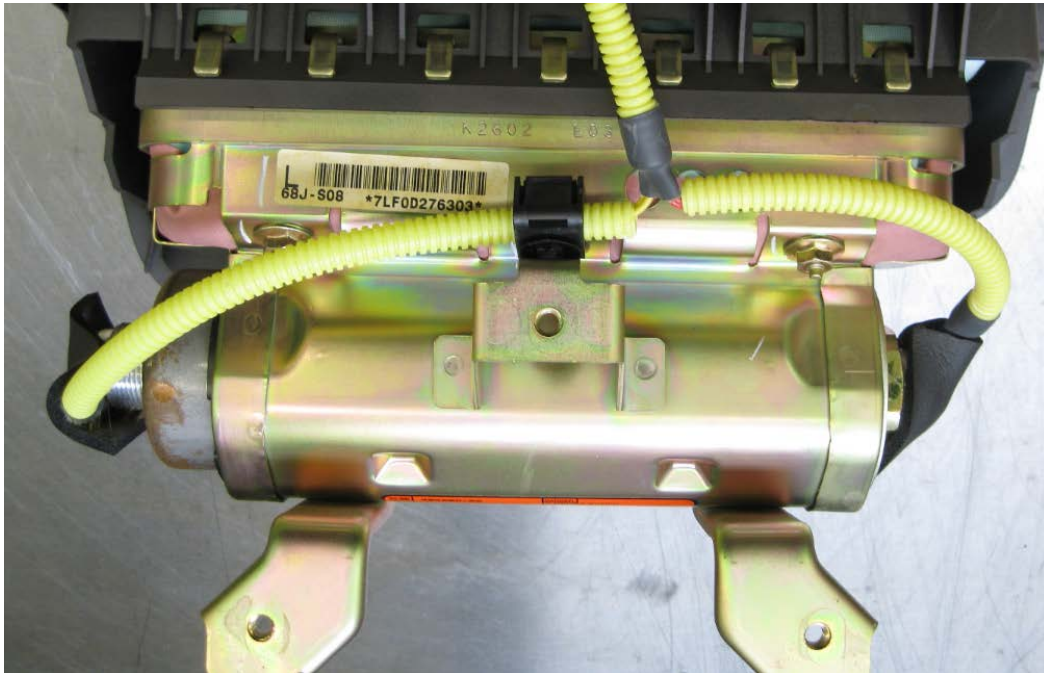
**Inflator WITHOUT Ammonium Nitrate- Serial Number Label Location (2003 Legacy, Outback and Baja models only):** Record this 12-digit number for claims purposes.

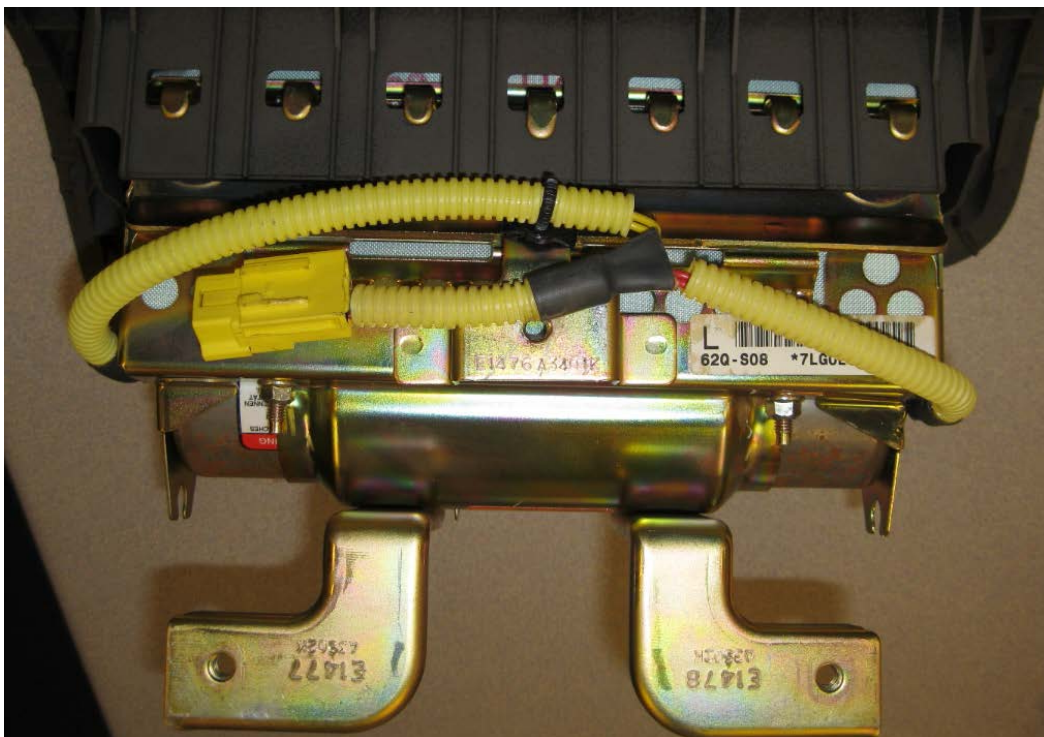
**Inflator WITH Ammonium Nitrate- Serial Number Label Location**
