PRODUCT CAMPAIGN BULLETIN

APPLICABILITY: 2003-2006 model year Baja
 2003-2004 model year Legacy
 2003-2004 model year Outback
 2009-2011 model year Legacy
 2009-2011 model year Outback
 2009-2011 model year Forester
 2006-2011 model year Tribeca
 2006-2011 model year Impreza (including WRX and STI)

NUMBERS: TKA-16R
 TKB-16R
 TKC-16R
DATE: 07/13/16
REVISED: 08/09/16
NHTSA ID: 16V-358
 16V-359
 16V-361

SUBJECT: Takata Front Passenger Airbag Inflator Replacement

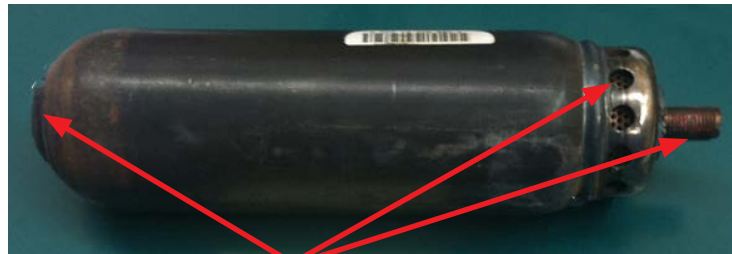
The shape, holes, and copper-colored stud indicate this not a Genuine Subaru inflator.

- **Do not proceed with this repair if your inspection reveals a non-Genuine Subaru air bag module has been installed in the vehicle.** Follow the instructions described in the “Counterfeit Air Bag Information” Dealer Advisory Bulletin.

- Document the presence of the aftermarket or counterfeit device on the repair order and with photos. Report this information immediately on a Quality Monitoring Report (QMR).

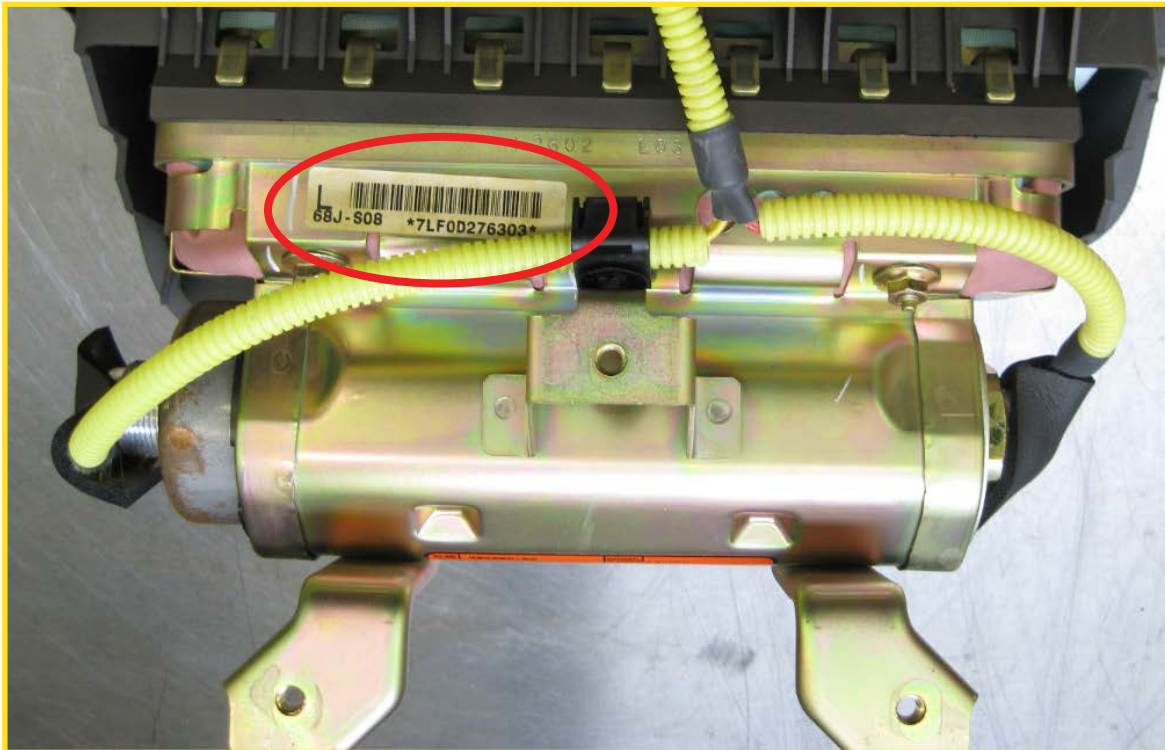
Autoliv Inflator Equipped Airbag- Serial Number Label Location
(Record this 12-digit number for claims purposes.)

- These vehicles were NOT equipped with inflators manufactured by Takata.
- These early production 2003 MY vehicles (77,000) were equipped with inflators produced by Autoliv.
- Autoliv produced inflators do not contain ammonium nitrate and are not included in any Takata inflator recall.
- These Autoliv inflators do not require replacement as part of any Subaru airbag recall.

See the Claim Reimbursement and Entry Procedures at the end of this announcement for instructions on how to submit a claim for “Inspection Only” when an Autoliv inflator is found.
