PRODUCT CAMPAIGN BULLETIN

<p>APPLICABILITY: 2003-2006 model year Baja 2003-2004 model year Legacy 2003-2004 model year Outback 2009-2011 model year Legacy 2009-2011 model year Outback 2009-2011 model year Forester 2006-2011 model year Tribeca 2006-2011 model year Impreza (including WRX and STI)</p>	<p>NUMBERS: TKA-16R TKB-16R TKC-16R</p> <p>DATE: 07/13/16</p> <p>REVISED: 09/27/16</p> <p>NHTSA ID: 16V-358 16V-359 16V-361</p>
---	---

SUBJECT: Takata Front Passenger Airbag Inflator Replacement

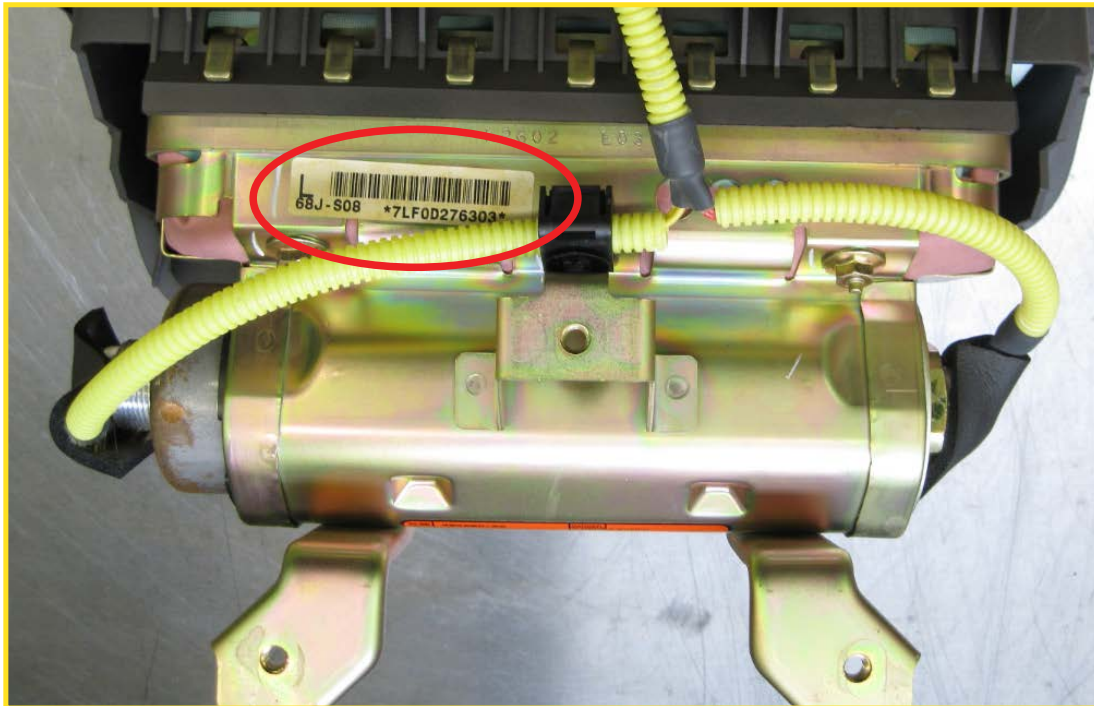
Inflator WITHOUT Ammonium Nitrate- Serial Number Label Location (2003 Legacy, Outback and Baja models only): Record this 12-digit number for claims purposes.

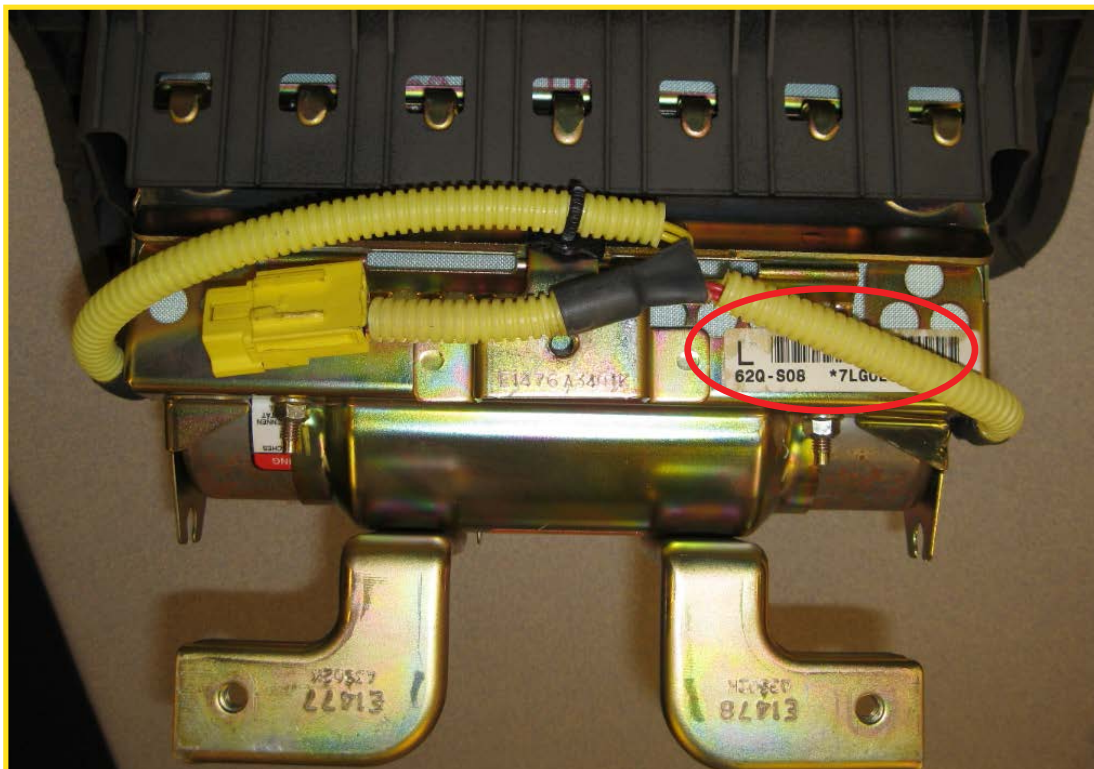
Inflator WITH Ammonium Nitrate- Serial Number Label Location
