PRODUCT CAMPAIGN BULLETIN

<p>APPLICABILITY: 2003-2006 model year Baja 2003-2004 model year Legacy 2003-2004 model year Outback 2009-2011 model year Legacy 2009-2011 model year Outback 2009-2011 model year Forester 2006-2011 model year Tribeca 2006-2011 model year Impreza (including WRX and STI)</p>	<p>NUMBERS: TKA-16R TKB-16R TKC-16R</p> <p>DATE: 07/13/16</p> <p style="background-color: #f1c40f;">REVISED: 03/06/18</p> <p>NHTSA ID: 16V-358 16V-359 16V-361</p>
---	--

SUBJECT: Takata Front Passenger Airbag Inflator Replacement

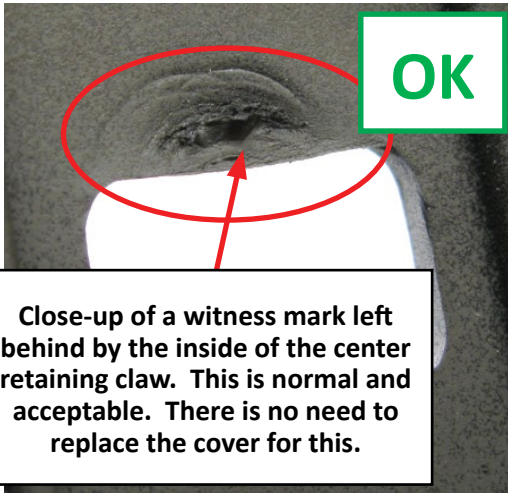
Close-up of a witness mark left behind by the inside of the center retaining claw. This is normal and acceptable. There is no need to replace the cover for this.

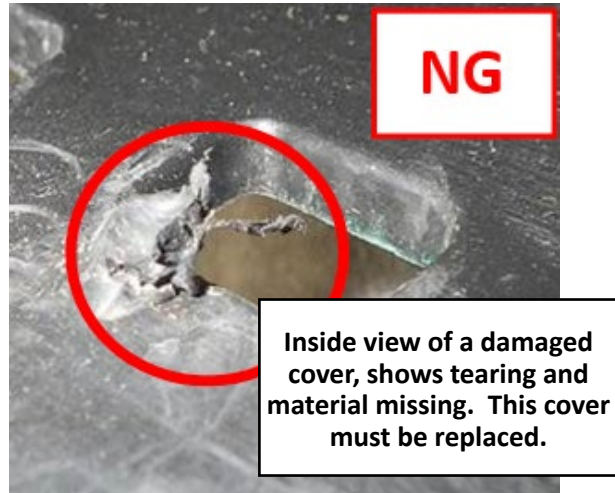
Inside view of a damaged cover, shows tearing and material missing. This cover must be replaced.

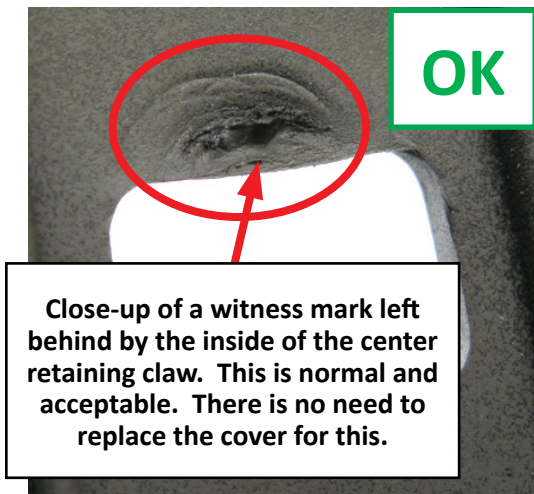
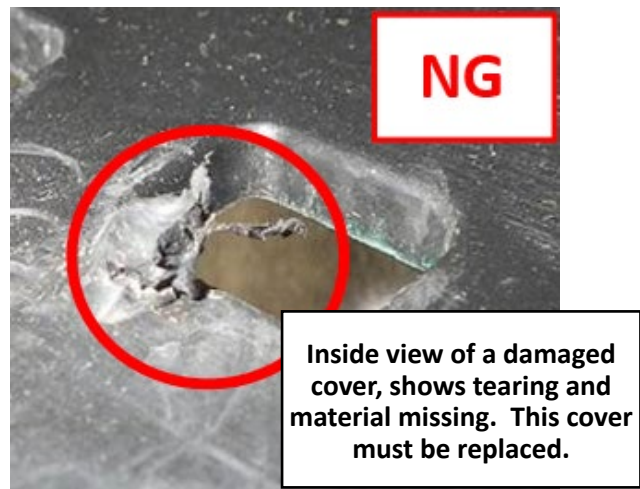
- Inspect the claw openings on the outside and inside of the cover for damage. If any found to look like the NG example photo below, the cover must be replaced.
