## PRODUCT CAMPAIGN BULLETIN

**NUMBERS:** TKA-16R  
 TKB-16R  
 TKC-16R  
**DATE:** 07/13/16  
**REVISED:** 01/05/17  
**NHTSA ID:** 16V-358  
 16V-359  
 16V-361

**SUBJECT:** Takata Front Passenger Airbag Inflator Replacement

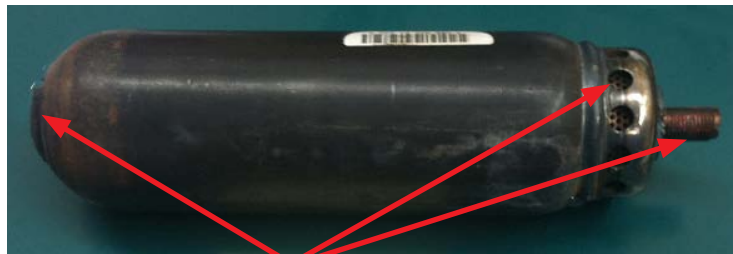
The shape, holes, and copper-colored stud indicate this not a Genuine Subaru inflator.

- **Do not proceed with this repair if your inspection reveals a non-Genuine Subaru air bag module has been installed in the vehicle.** Follow the instructions described in the “Counterfeit Air Bag Information” Dealer Advisory Bulletin.

- Document the presence of the aftermarket or counterfeit device on the repair order and with photos. Report this information immediately on a Quality Monitoring Report (QMR).
