**PRODUCT CAMPAIGN BULLETIN**

<p><b>APPLICABILITY:</b> 2003-2006 model year Baja          2003-2004 model year Legacy          2003-2004 model year Outback          2009-2011 model year Legacy          2009-2011 model year Outback          2009-2011 model year Forester          2006-2011 model year Tribeca          2006-2011 model year Impreza (including WRX and STI)</p>	<p><b>NUMBERS:</b> TKA-16R          TKB-16R          TKC-16R</p> <p><b>DATE:</b> 07/13/16</p> <p style="background-color: #ffc107;"><b>REVISED:</b> 04/21/17</p> <p><b>NHTSA ID:</b> 16V-358          16V-359          16V-361</p>
---	--

**SUBJECT:** Takata Front Passenger Airbag Inflator Replacement

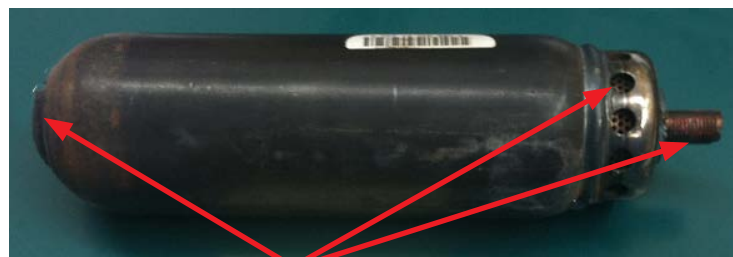
**The shape, holes, and copper-colored stud indicate this not a Genuine Subaru inflator.**

- **Do not proceed with this repair if your inspection reveals a non-Genuine Subaru air bag module has been installed in the vehicle.** Follow the instructions described in the “Counterfeit Air Bag Information” Dealer Advisory Bulletin.

- Document the presence of the aftermarket or counterfeit device on the repair order and with photos. Report this information immediately on a Quality Monitoring Report (QMR).
