## PRODUCT CAMPAIGN BULLETIN

**APPLICABILITY:** 2003-2006 model year Baja  
 2003-2004 model year Legacy  
 2003-2004 model year Outback  
 2009-2011 model year Legacy  
 2009-2011 model year Outback  
 2009-2011 model year Forester  
 2006-2011 model year Tribeca  
 2006-2011 model year Impreza (including WRX and STI)

**NUMBERS:** TKA-16  
 TKB-16  
 TKC-16  
**DATE:** 07/13/16  
**NHTSA ID:** 16V-358  
 16V-359  
 16V-361

**SUBJECT:** Takata Front Passenger Airbag Inflator Replacement

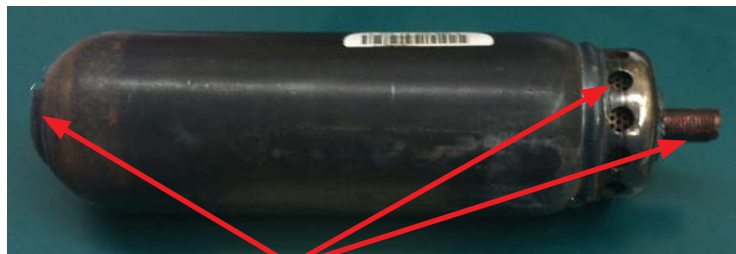
The shape, holes, and copper-colored stud indicate this not a Genuine Subaru inflator.

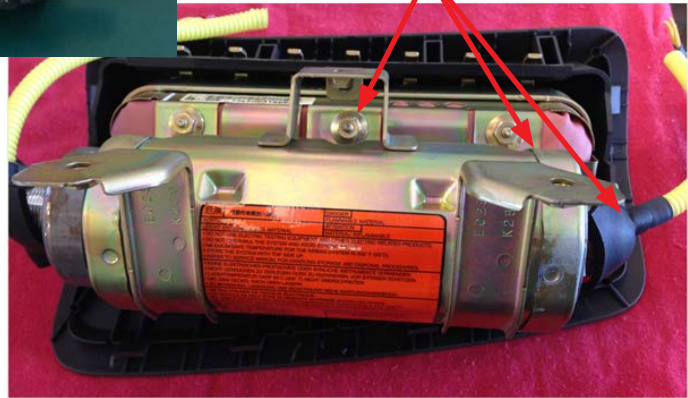
No visible stopper plates, a 6-nut configuration and rubber harness boots are other examples to indicate this is not a Genuine Subaru airbag module.
