SI B65 19 16
Audio, Navigation, Monitors, Alarms, SRS

September 2017
Technical Service

RECALL 16V-364: PASSENGER'S FRONT AIR BAG MODULE

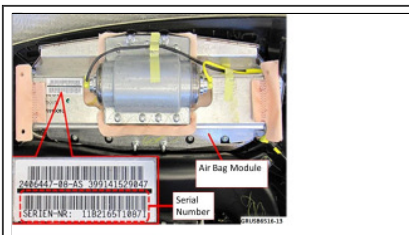
Before installing the replacement part, the new air bag module's serial number must be documented by the technician on the repair order so it can also be entered into the warranty claim's comment section.

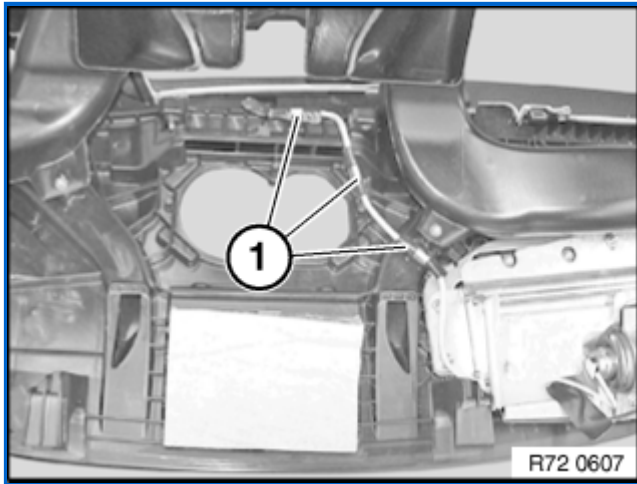
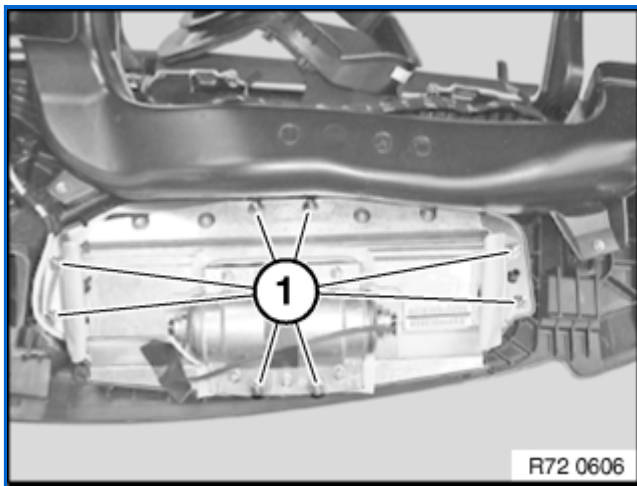
Unclip airbag lead with holders (1) from instrument panel.

Unscrew nuts (1).
