P081NAS1

# TECHNICAL BULLETIN

SAFETY RECALL: Takata Passenger Airbag

MODEL:	MODEL YEAR:	VIN:	ASSEMBLY PLANT:
Range Rover (LM)	2007-2011	233807-360036	Solihull

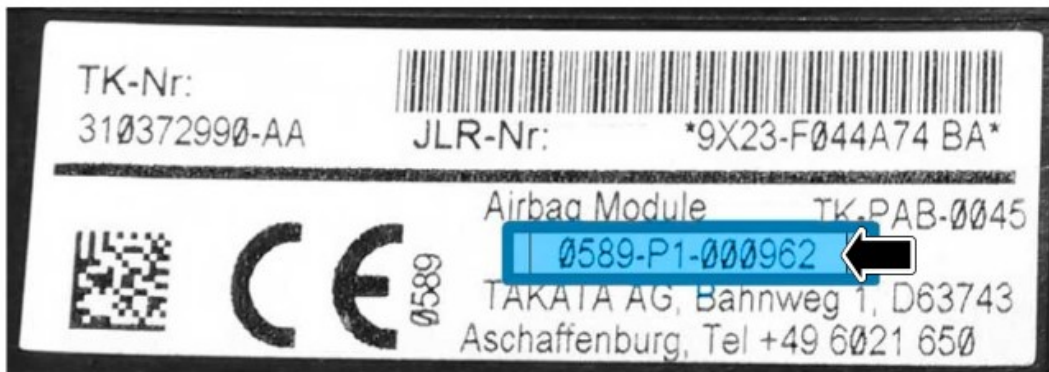
E206204

- **Order only the expected percentage demand of parts identified.**
- **The serial number of the new airbag module (example highlighted in blue) MUST be recorded on the claim verbatim.**

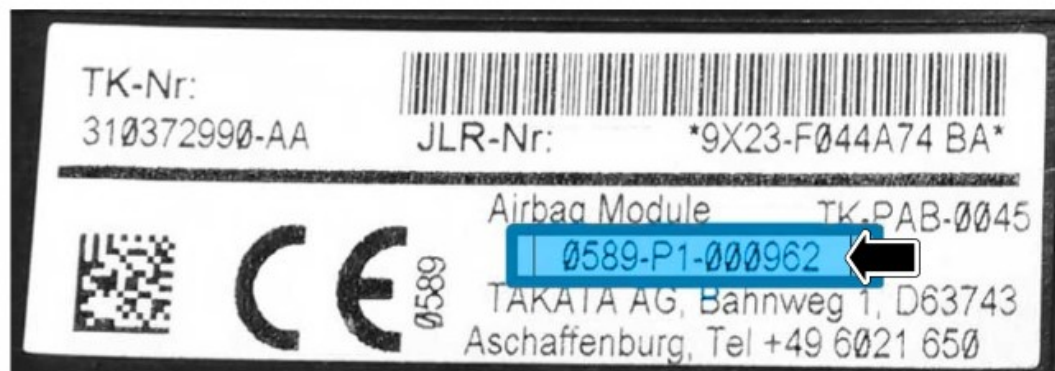
E206204

The serial number of the new airbag module (example highlighted in blue) MUST be recorded on the claim verbatim.

Locate and record the serial number of the new airbag module on the claim verbatim.
